# Accessibility Audit Report

**Institute of Home Economics**

University of Delhi

1.07.2026

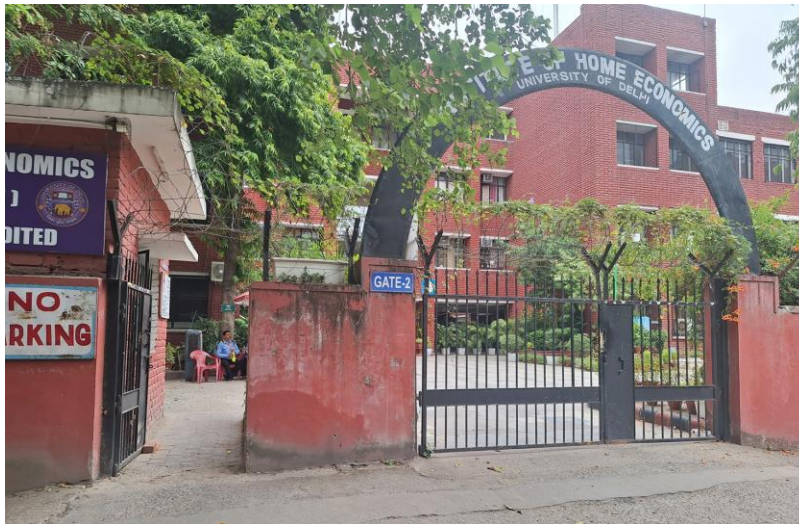
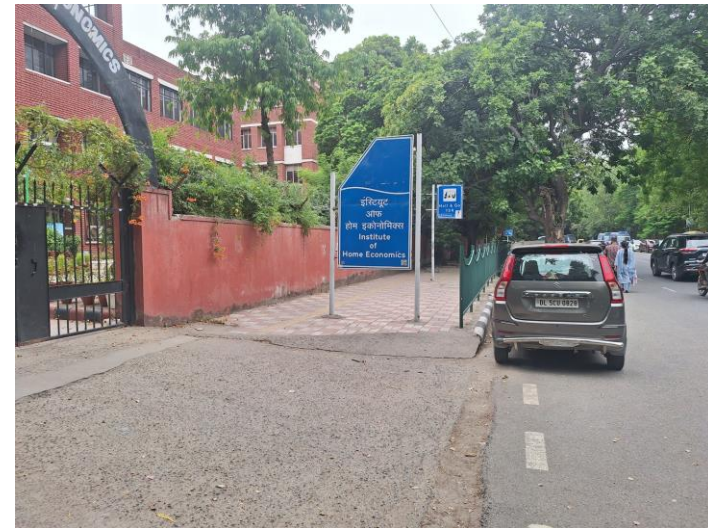
# Main Entrance – Gate 2

- Pedestrian and vehicular entry are segregated with two gates.
- Width of the pedestrian gate is 1060mm.
- Tactile Ground Surface Indicator (TGSi) warning at the entrance on either side of the pedestrian gate and TGSi guiding pavers till the admin block is also missing.

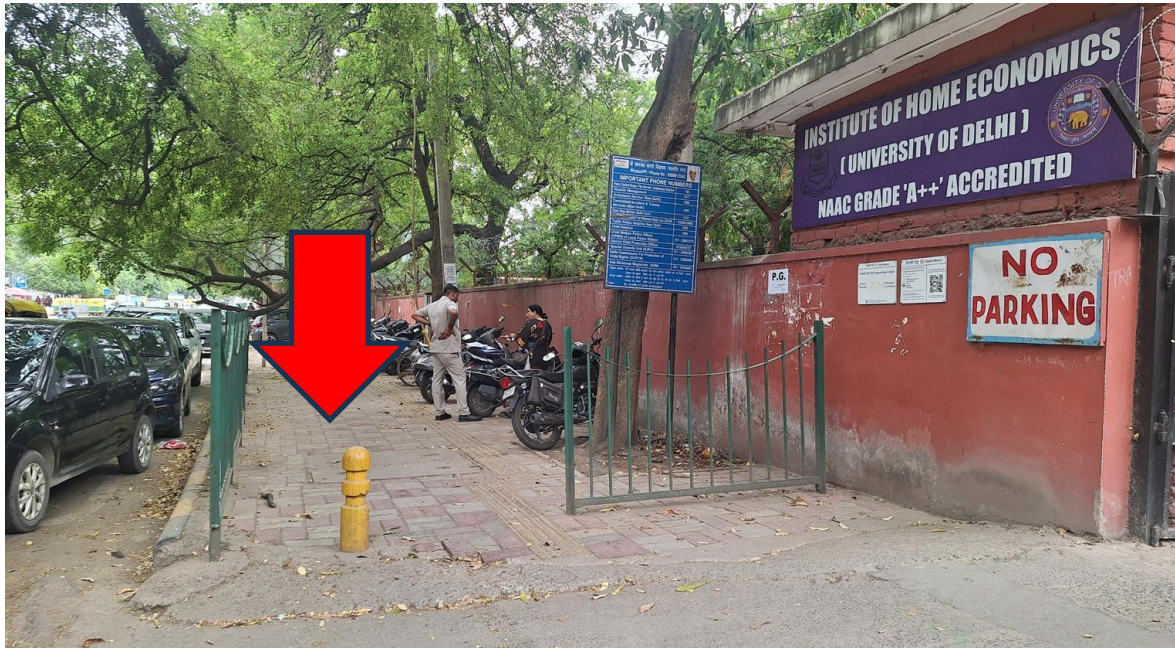
# Outdoor Parking (only for students) – Two wheelers

- Reserved parking for modified two wheelers for students with physical disabilities is missing.
- Floor marking and signage for accessible parking shall be provided.
- However the space utilised for two wheeler parking is sharing and close to the footpath next to the road.

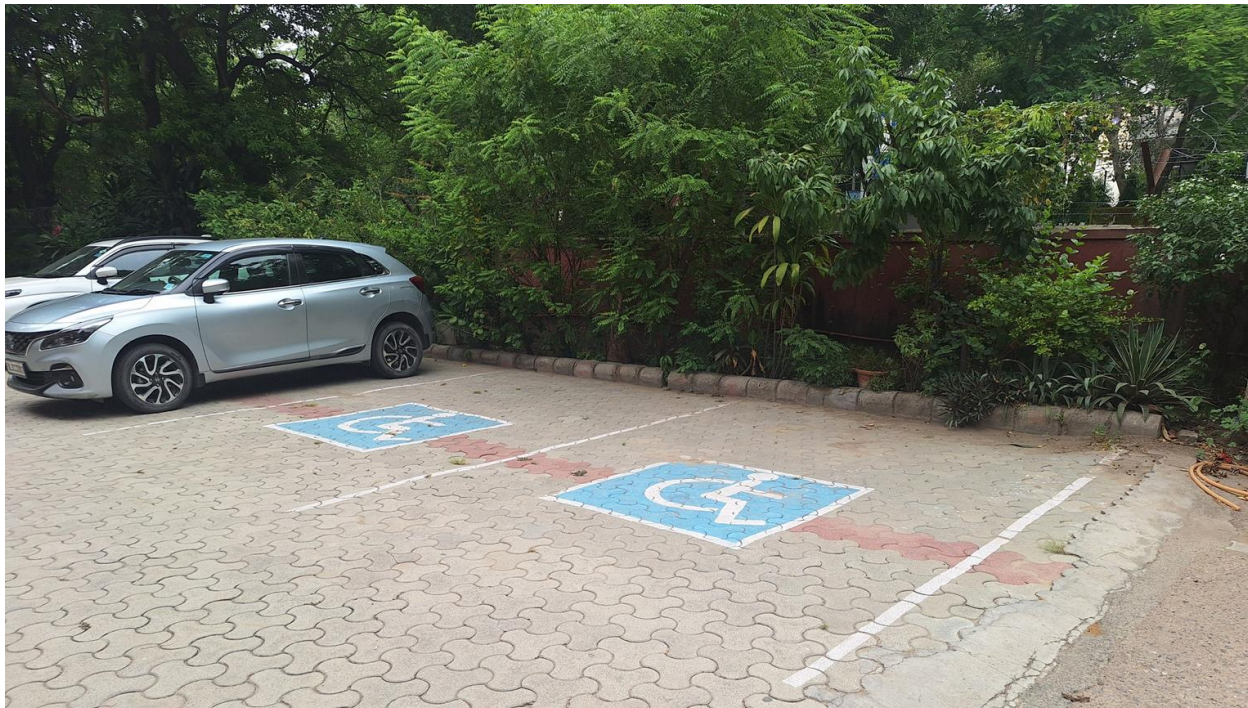
- Vertical signage with universal symbol for accessible parking is missing.
- The space allocated for each four wheelers is 3310mm x 4600mm.
- Reserved car parking space is given adjacent to the main gate only.

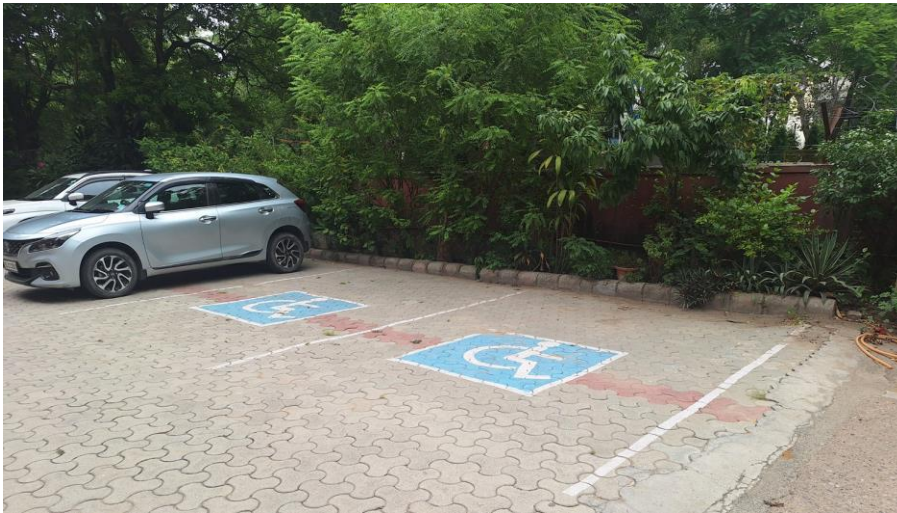
- Main entry kerb connecting pathway leading to the main entry is hidden due to parked vehicle in front of the kerb.
- TGSi warning is missing at the start and end of the kerb.
- TGSi guiding is not connected with this kerb and leading to the main entry.
- No designated surface parking is provided as this entry 6 is close to the main road.

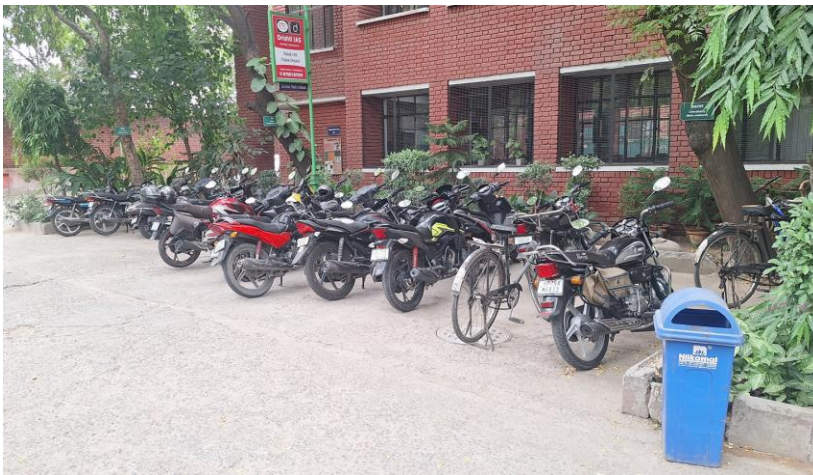
- Accessible parking signage and floor mark for reserved two wheelers is missing.
- The path connecting the two wheeler space from the main gate is not smooth for a staff with locomotive disability to commute, if the vehicle is parked in this space.

Existing Two wheeler space without reserved parking indication

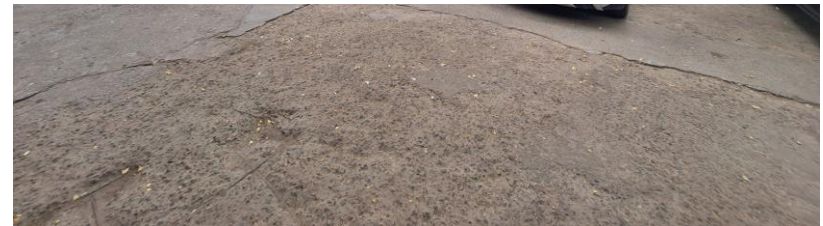
Damaged surface close to two wheeler parking space

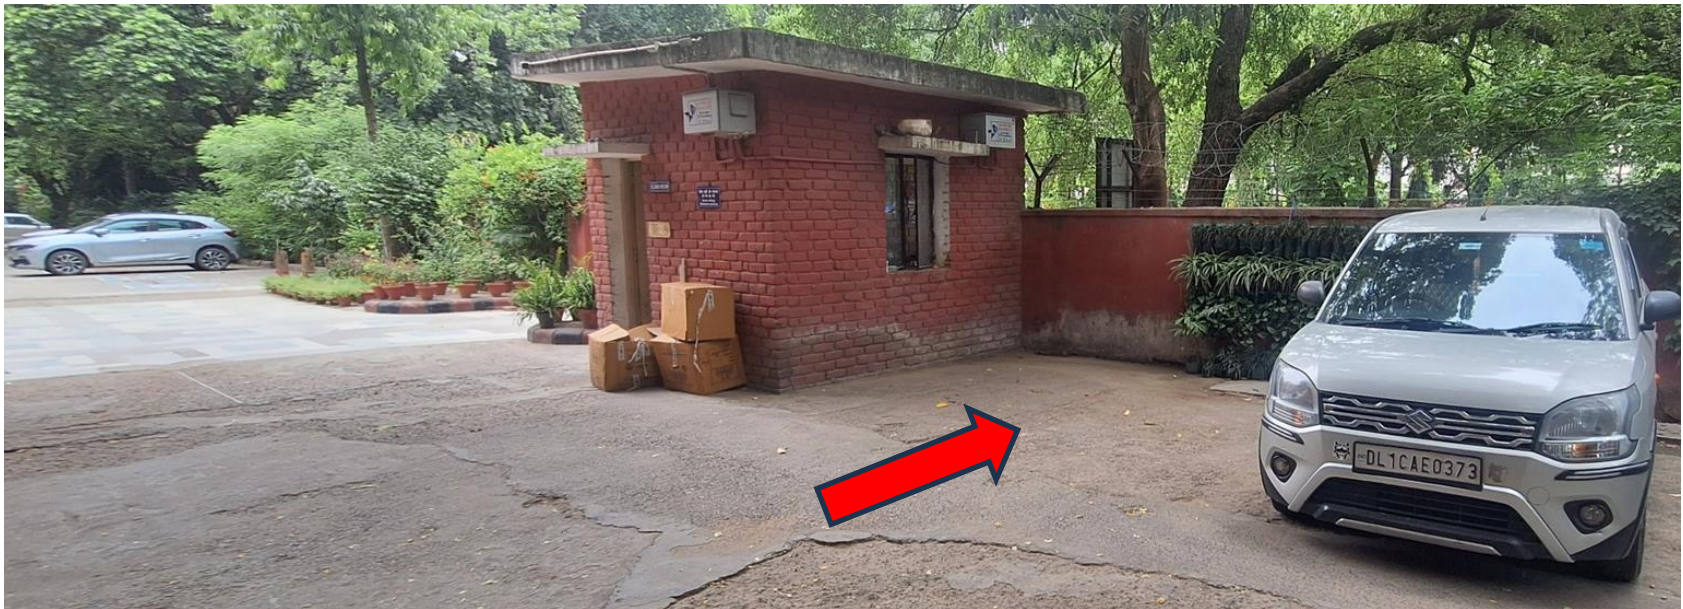
Recommended space for accessible two wheeler parking close to main entrance.

- Space identified for accessible two wheeler parking close to main entrance is recommended below:

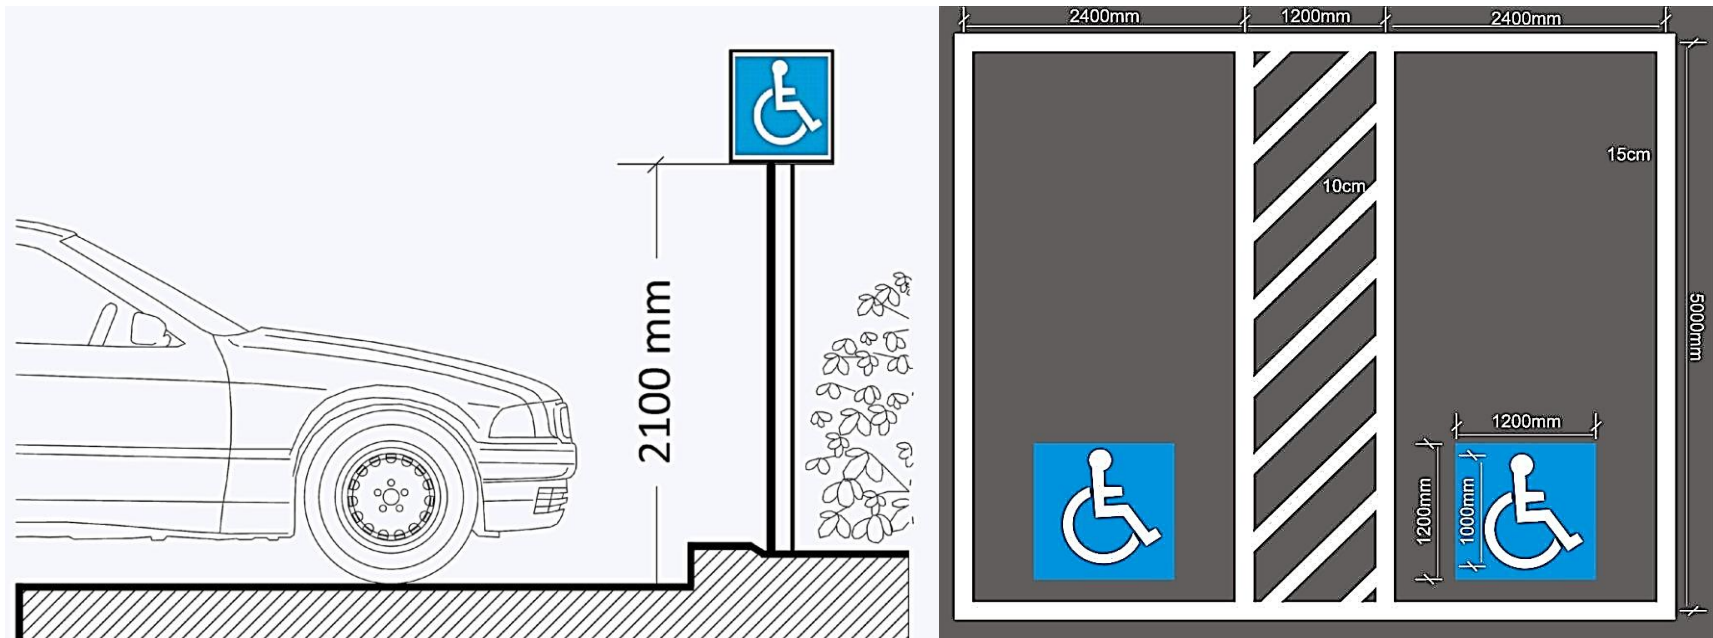
Signage and layout of accessible parking

- Accessible parking for four wheelers should be provided within 30 meters of the main entrance. Overall minimum dimension proposed for vehicle - 6000mm x 5000mm, including aisle space of 1200mm.
- Accessible parking signs should be positioned at 2100mm height, so that they can be seen even if cars are parked in the vicinity.
- Signage should be 600mm x 600mm size, which is easily identified from the driver's seat.

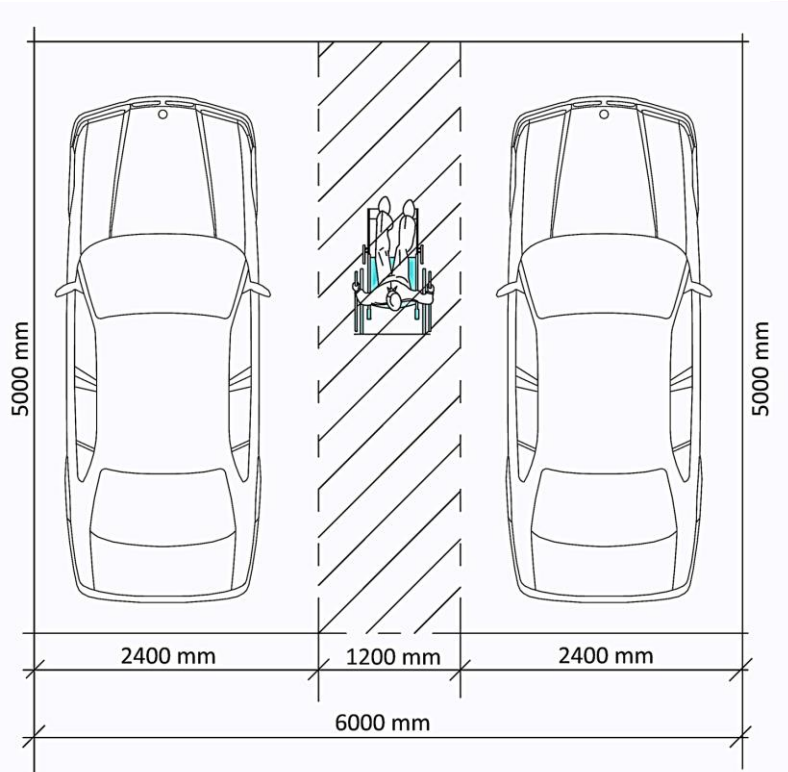
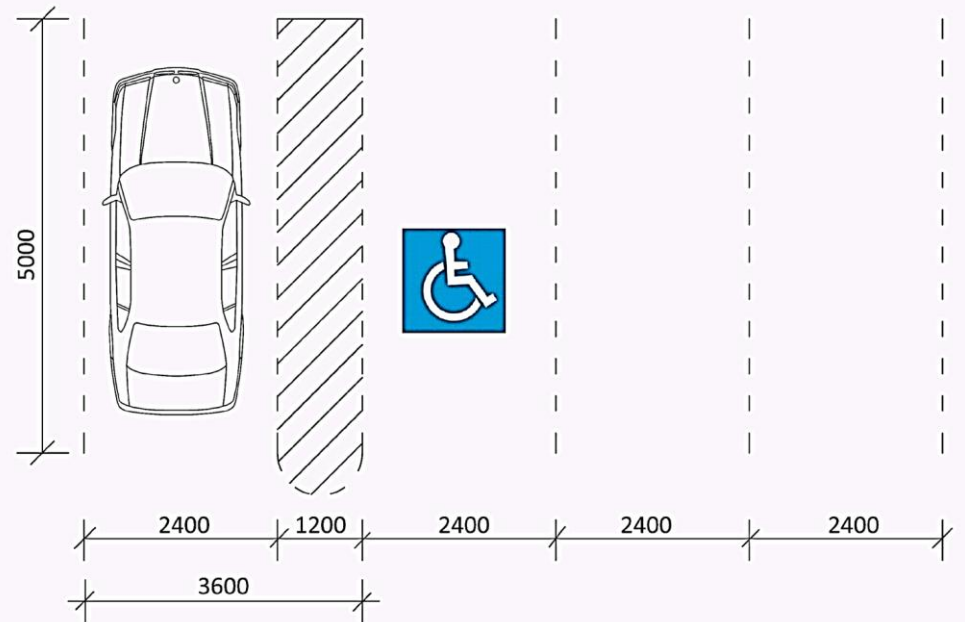
- Accessible parking for four wheelers should be provided as per illustrations.

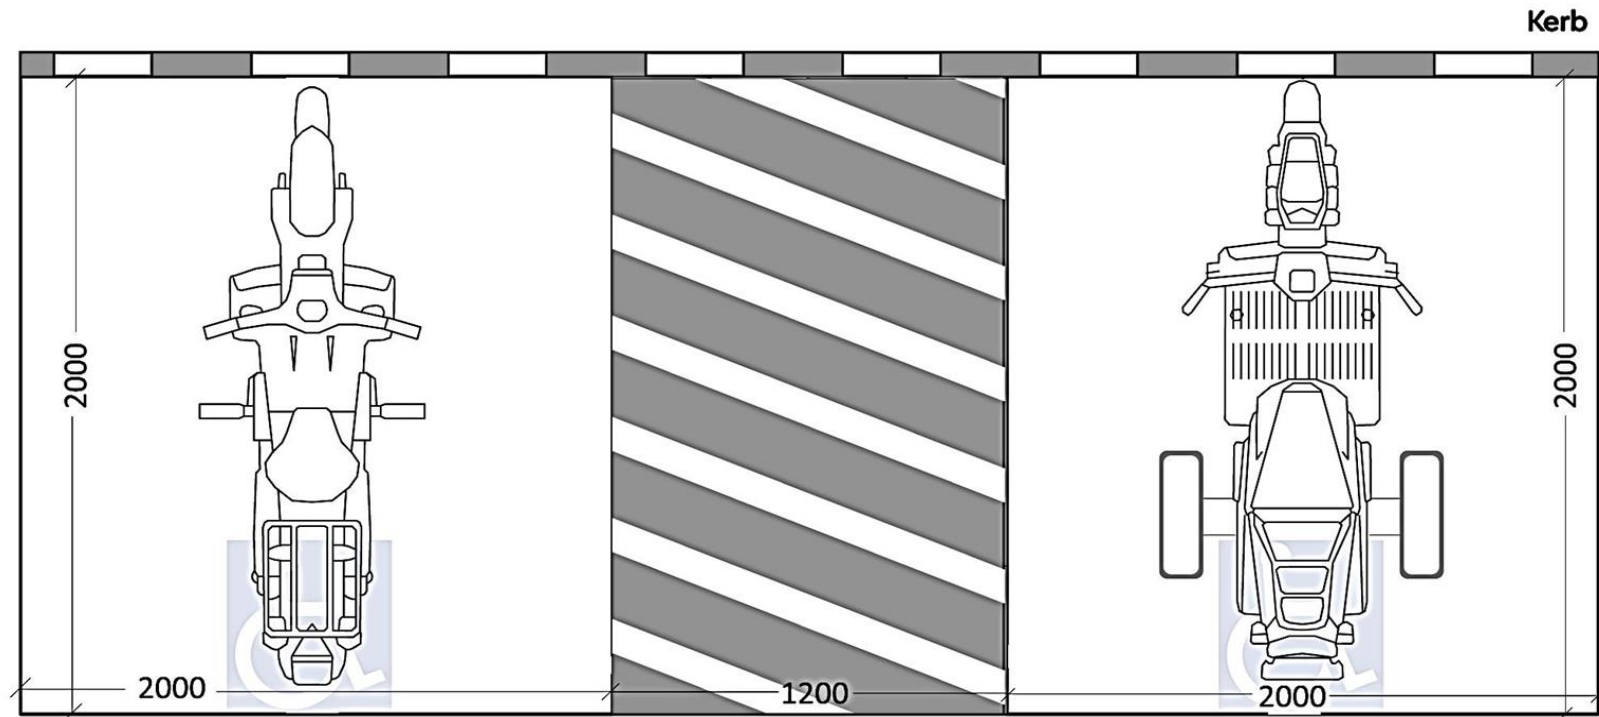
- For two wheelers used by persons with disabilities, reserve parking space shall be provided.

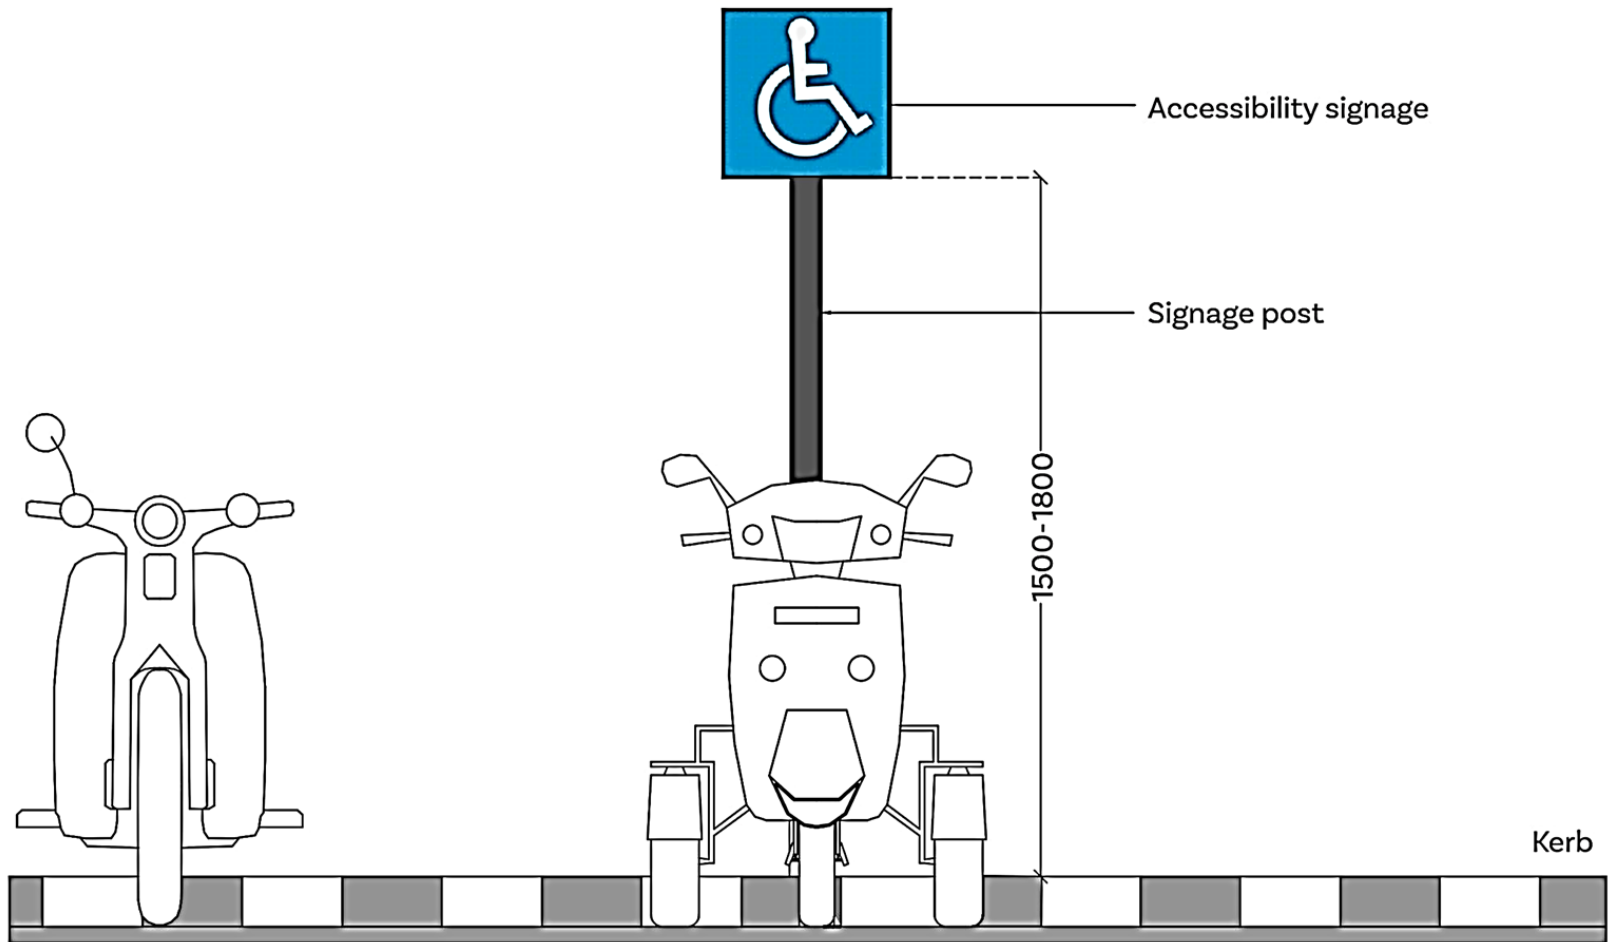
- Reserved parking space for adapted two wheeler/ tricycles should be provided in the two wheeler parking area with a signage for users for way finding.

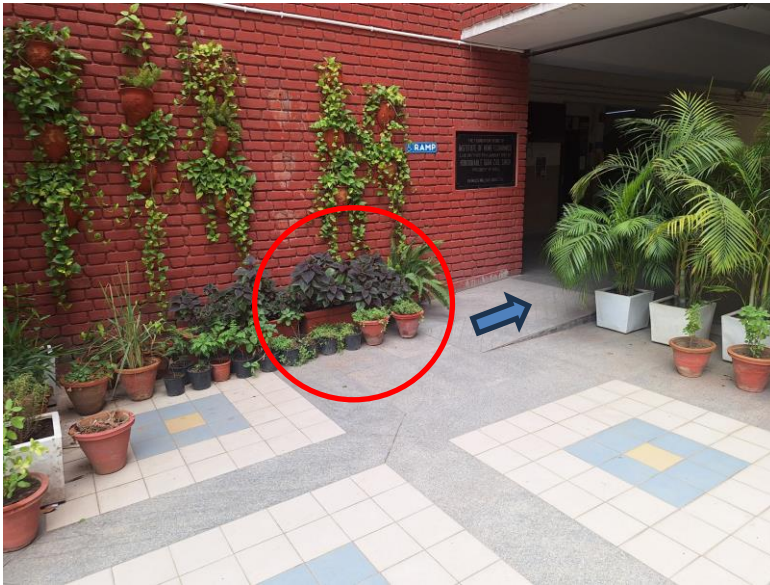
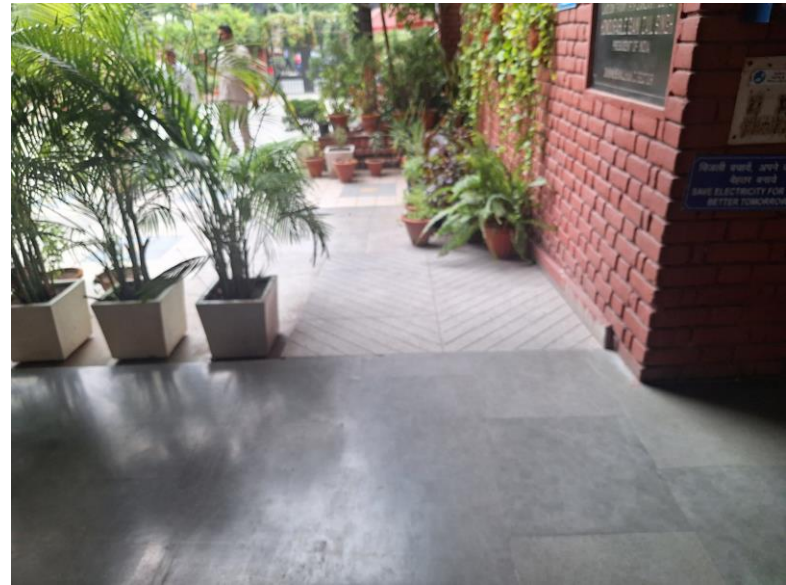
# Ramp Entry to Lobby/Admin

- Planters are hindrance to the ramp entry by reducing the sufficient width for wheelchair users or any person with locomotive disabilities to enter the lobby space.
- Handrail on the wall side is missing. The plinth height is 150mm.
- The length of the ramp is 1820mm and the width of the ramp is 1490mm. (Ramp slope ratio is 1:12)

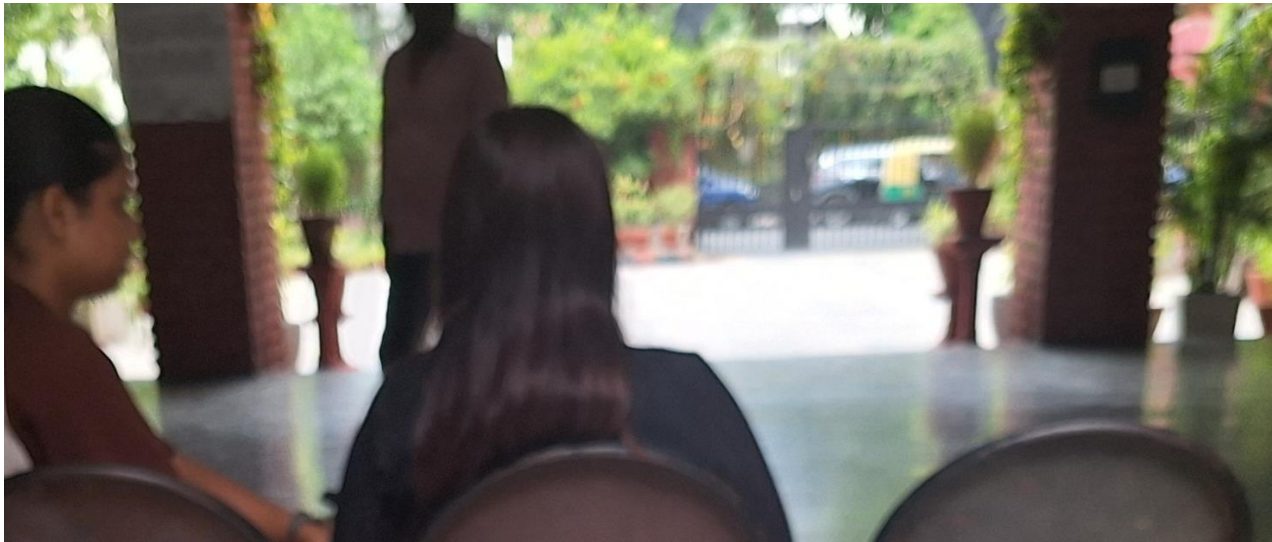
# Step Entry to Lobby/Admin

- Lobby is accessible from the central bay with a step. Bay at the either sides are covered with planters. Riser is 150mm.
- TGSi warning is missing at the start and end of the step for whole length of the lobby space with an offset of 300mm to warn the person with low vision.

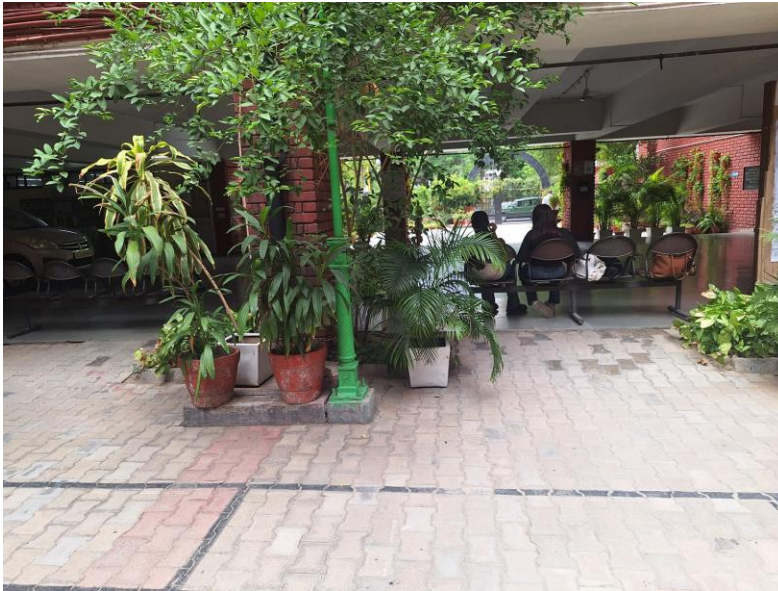
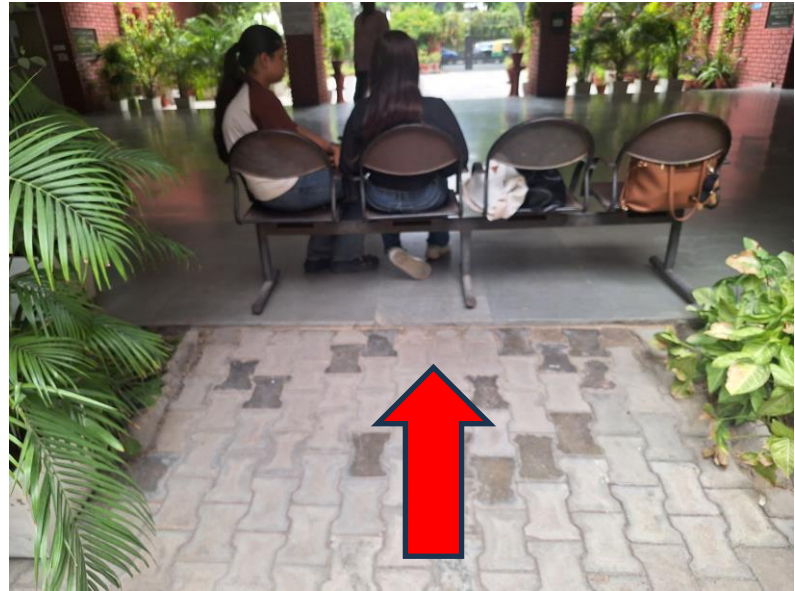
# Entry to central courtyard

- Central courtyard is connected with 2 ramps. The length of the ramp is 2100mm and width is 900mm. Level difference is -140mm.
- One of the ramp is blocked by provision of seating.
- TGSi warning at the start and end of the ramp is missing.

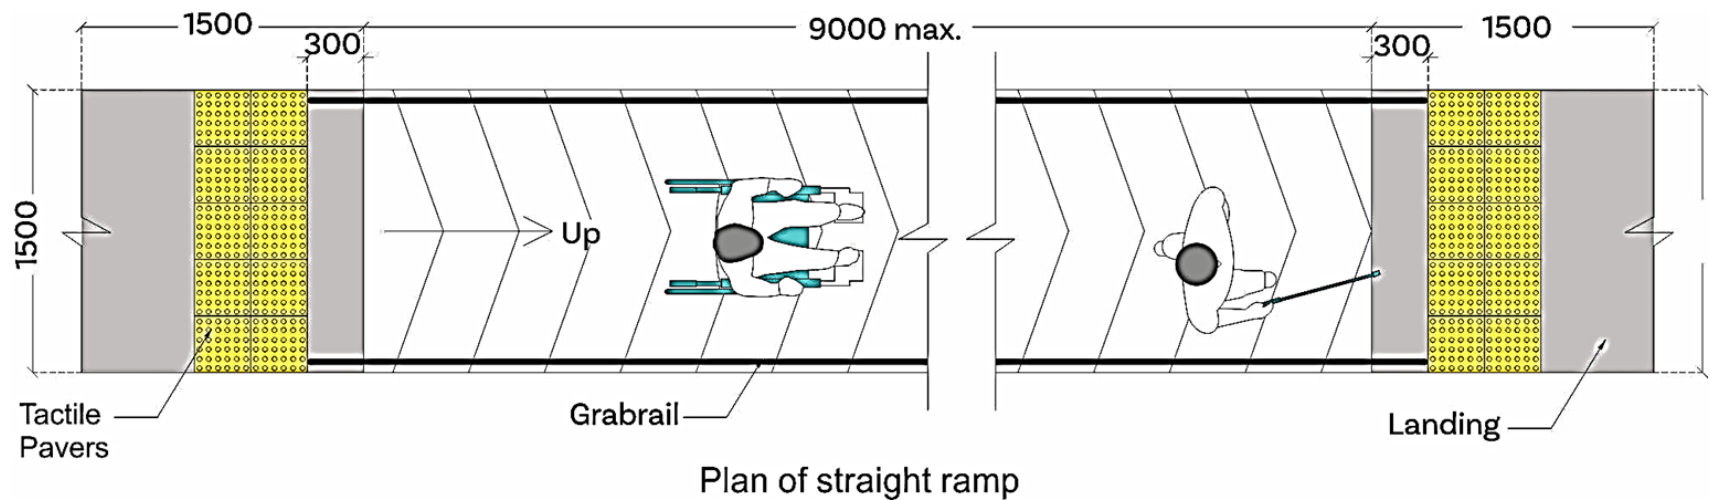
- Ramps should have a gentle slope of 1:12.
- The width of ramps shall be 1800 mm min. or as per the width of the existing door opening.
- Surfaces of ramps and landings should be slip resistant/anti-skid.
- Handrails: for plinth height above 150mm, handrails should be provided on both sides of the ramp, at two levels and at a height of 760 mm and 900 mm; both ends of the handrails should be rounded and grouted and extend 300 mm beyond top and bottom of ramp.
- Strips of warning pavers should be placed 300 mm before the beginning of the ramp and after the ending of the ramp.

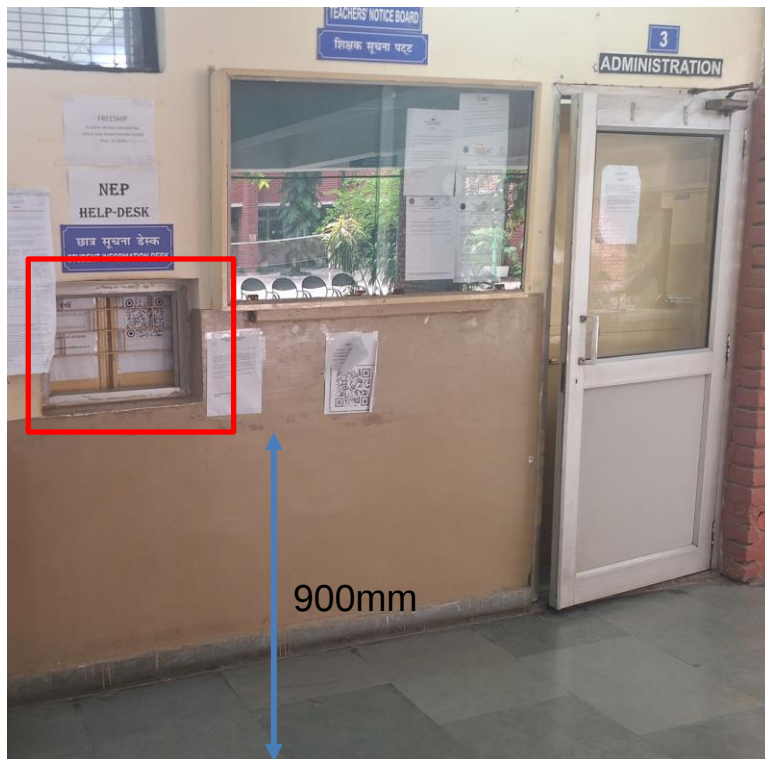
- The distance between the information desk and the finished floor is 900mm.
- TGSi warning in front of the information counter shall be provided.

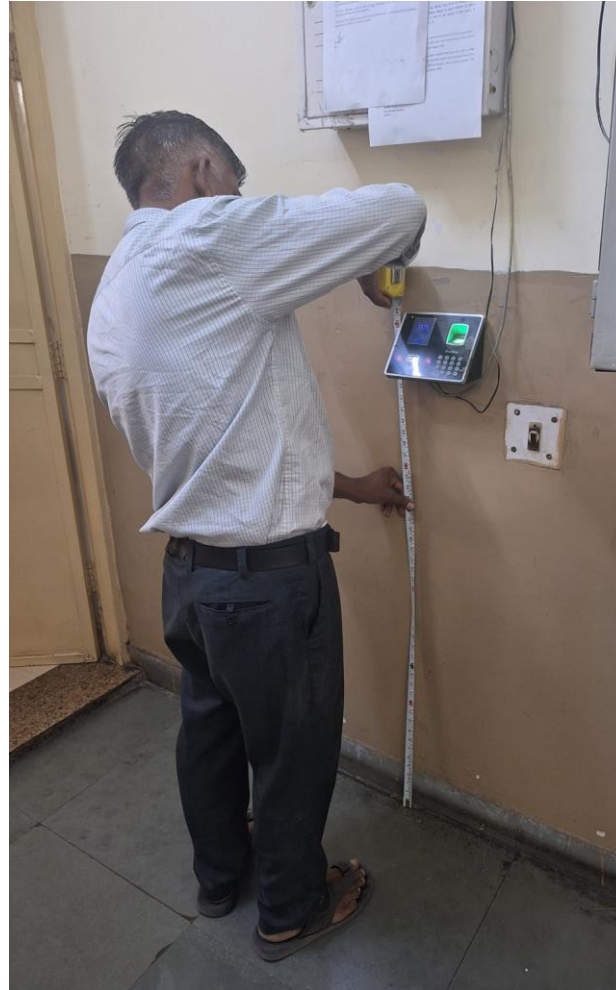
# Attendance – Biometric machine

- Height of the biometric machine is 1210mm.

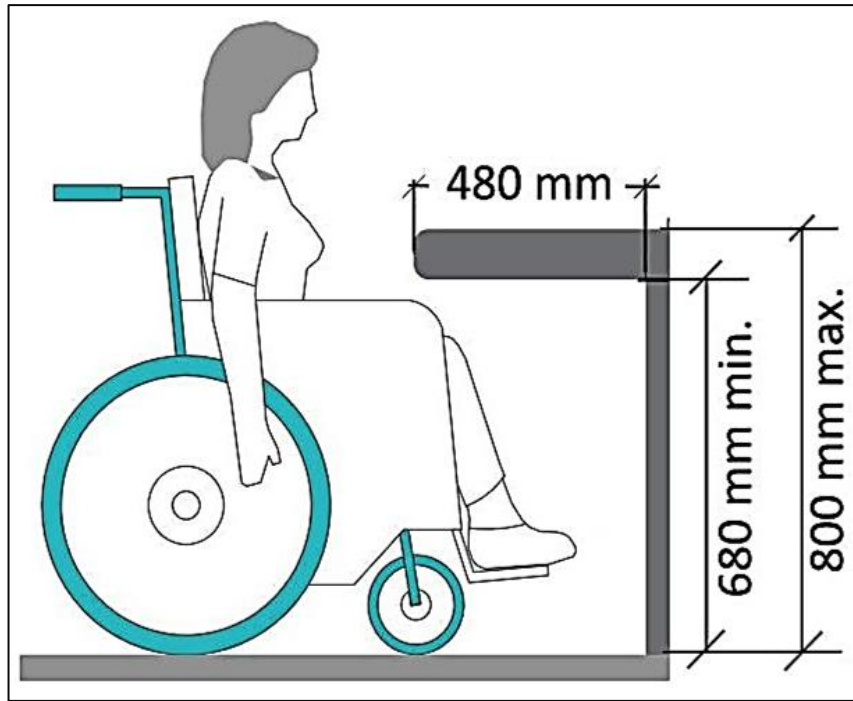
- Public dealing counters /table top should not be more than 800mm from the floor, with a minimum clear knee space of 670mm high and 280mm-300mm deep.
- Tactile paver should be provided for every counter.

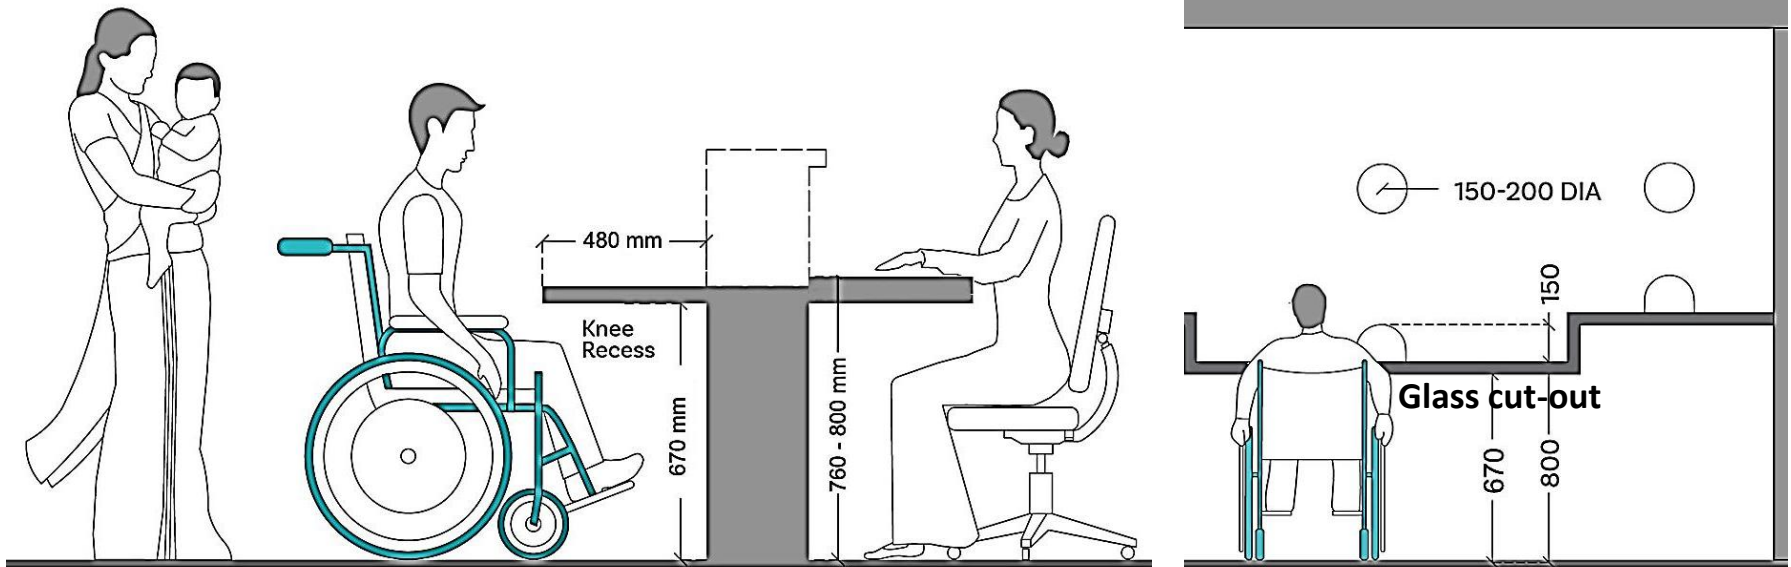
- On the visitors side, there should be leg and knee space should be 670mm
- On employee side, it should be 760-800mm

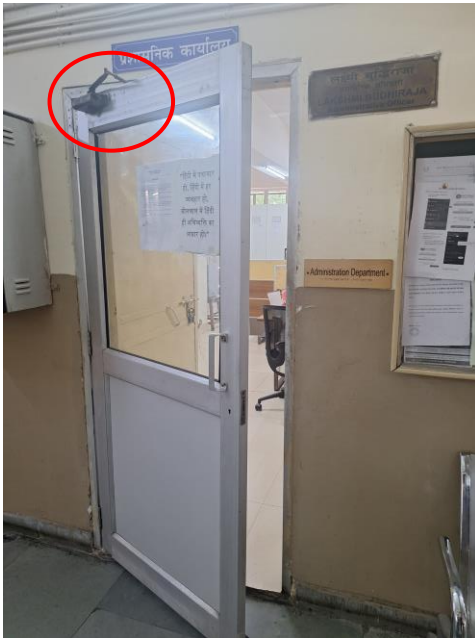
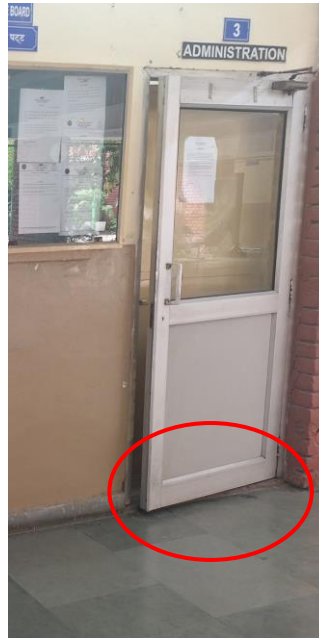
# Entry to Admin office space

- There are 2 doors connecting the admin office from corridor space.
- Both are raised with 50mm from the finished floor level.
- 2 doors, one opening outside with automatic door closer and an another opening inside.

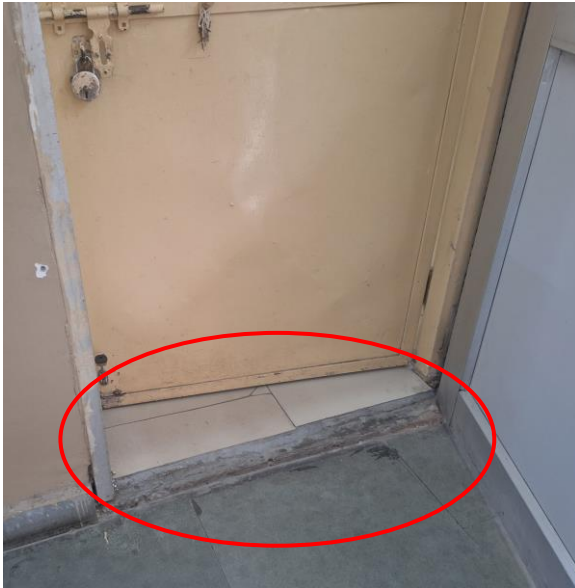
# Entry to Admin office space, Directors room and pantry

- Bevelled edges shall be provided to have smooth transition from corridor space to the office space and other adjacent rooms (Directors room, pantry) .

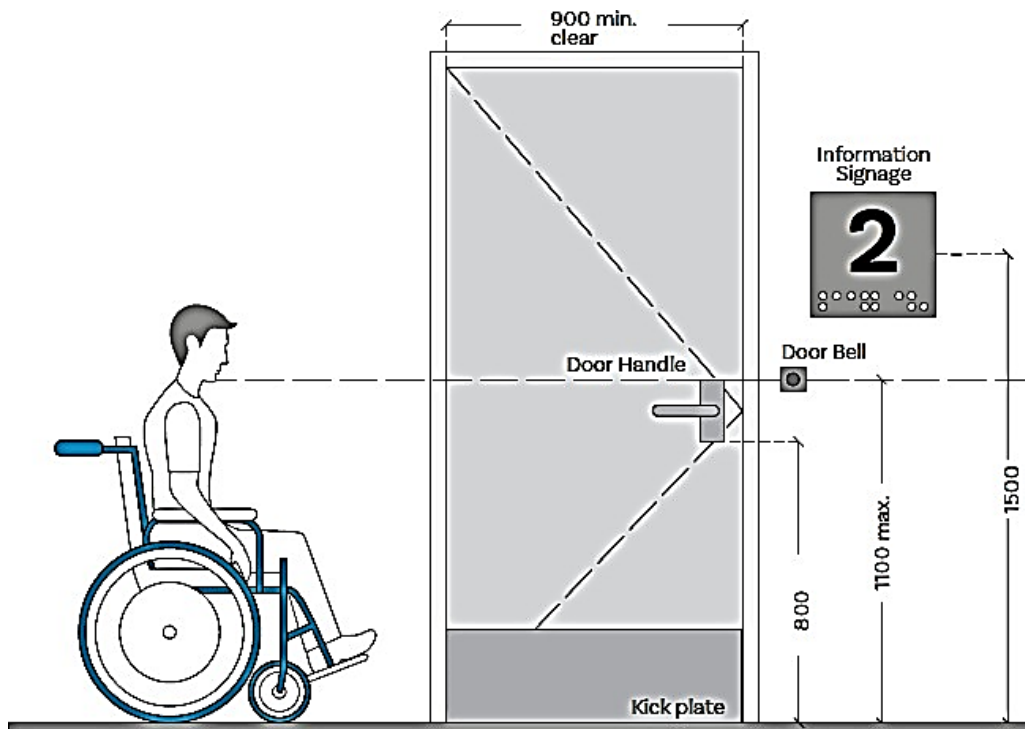
- For all two leaf door, one should not be less than 900mm wide.
- It is safer to use D-shaped handles as they reduce the risk of catching on clothing, or injuring from the exposed lever end.

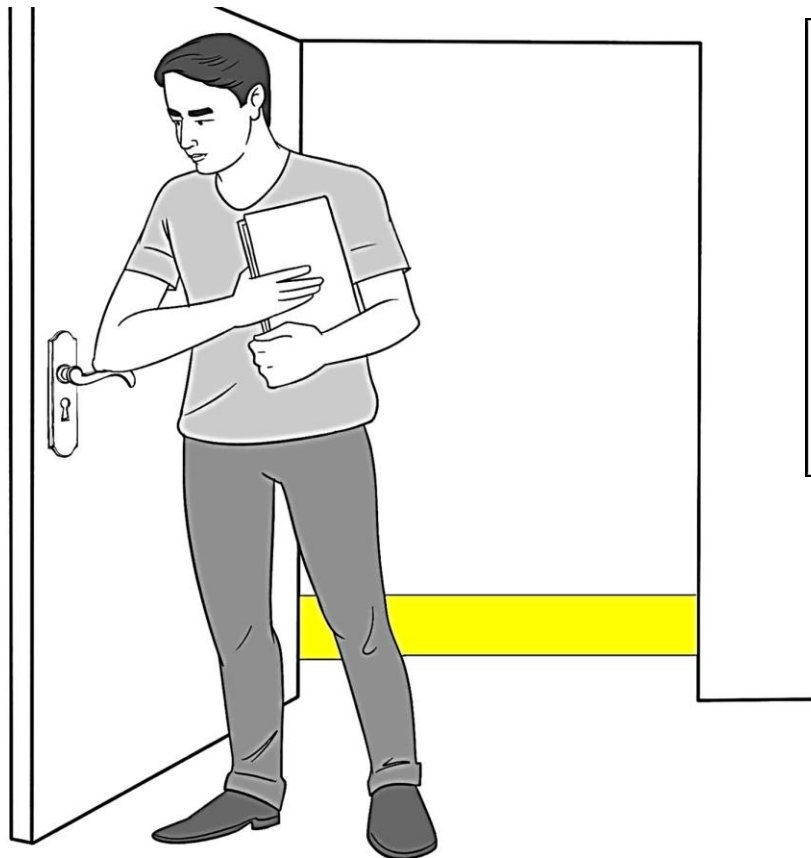
- Doors should be fitted with a lever action locks and D-handles of circular section, between 800mm and 1100mm from floor level.
- Doorknob is not recommended, as it does not provide adequate grip for persons with impaired hand functions.

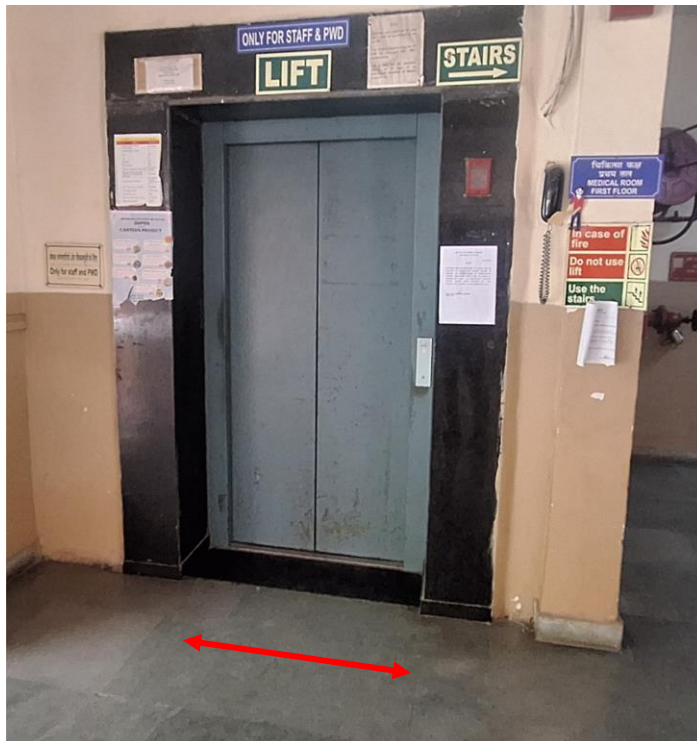
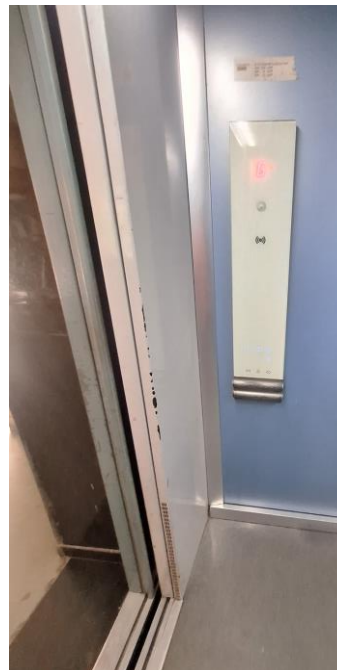
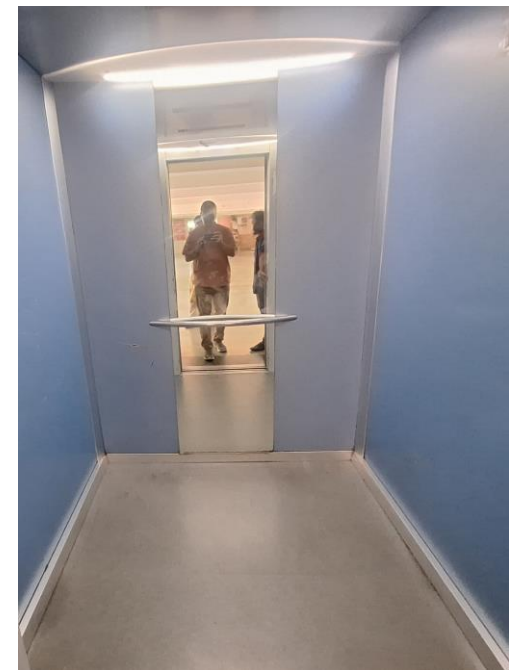
- TGSi warning is missing in front of the lift door opening.
- Size of the lift is 1590mm x 1504mm.
- Switch button is at the height of 966mm.
- Braille signage is not integrated onto the control panels. Also, the audio communication system/audible announcement status needs verification or repair.
- Height of the control panel is at 1012mm from the finish finished lift car floor level.
- Handrails at either side of the lift car is not provided. Mirror is fixed in the opposite side of the door.
- Signage for every floor level opposite to the lift is missing.

- Lift lobby to have ceiling hung floor number for easy identification of floor by the visitors.
- Tactile pavers should be provided, marking the door and call button also.

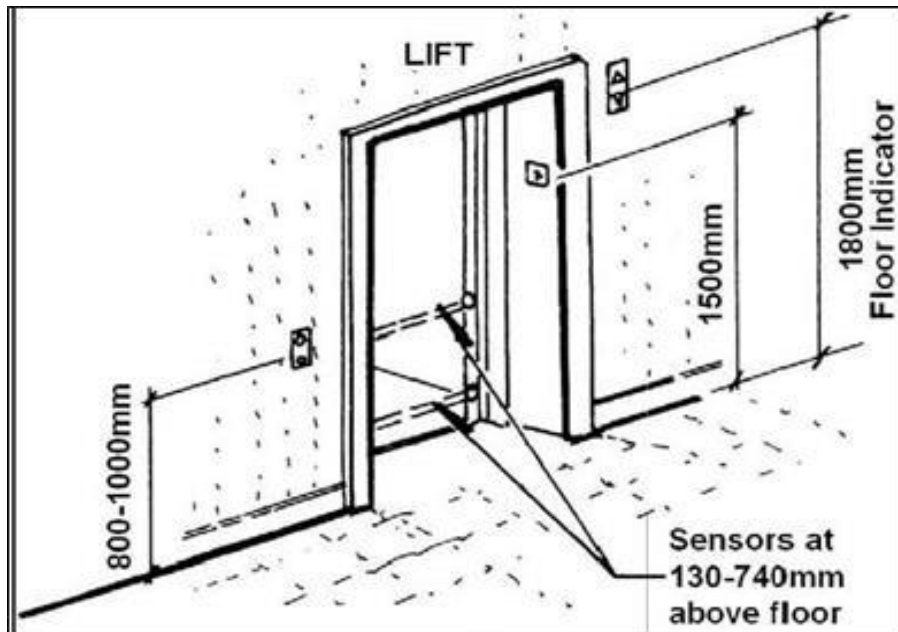
- Call button & control panel: At a reach of 800 mm – 1000 mm; at least 400 mm from any corner or have a clear floor space of at least 900 mm x 1200 mm with no obstruction placed to prevent a wheelchair user from reaching the call button;
- Control panel: Have buttons with Braille/ raised letters and in sharp contrast from the background to aid persons with low vision.
- Rear view mirror to be fitted.
- Grab bars/handrails in the lift shall be provided; outer diameter shall be 38mm
  - Be placed at a height of 800mm from the floor level; and
  - Be fixed on both sides and at the rear of the lift (i.e. all 3 sides of the lift).

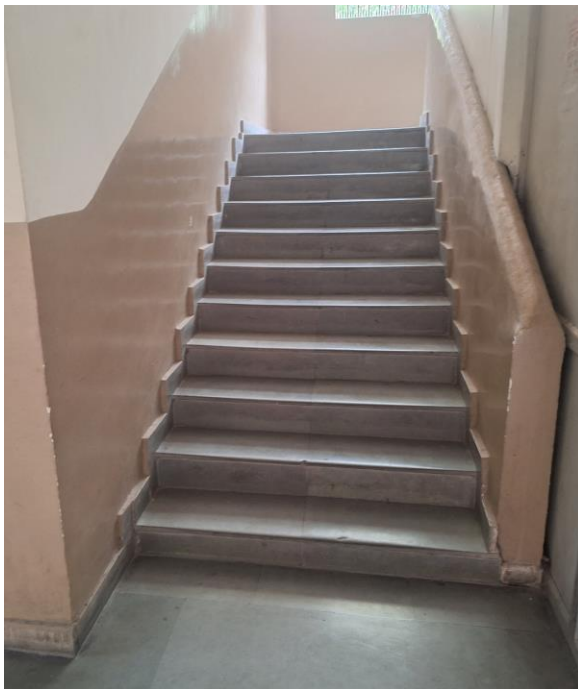
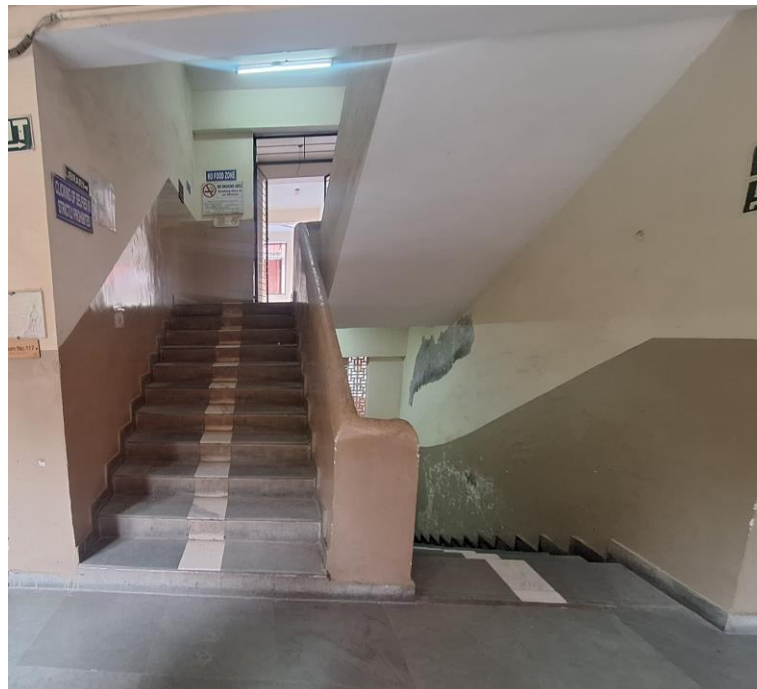
- TGSi warning is missing in the start and end of the steps including landing of the staircase.
- Handrail is missing on one side of the staircase.
- Extension of handrail on the other side to reach for person with mobility issues from the corridor level with an extension of 300mm is missing.
- Width of the step is 1360mm, height of the handrail on one side is 905mm. First step riser height is 106mm.
- Antiskid edges for each step is missing.
