# Accessibility Audit Report

**Institute of Home Economics**

University of Delhi

1.07.2026

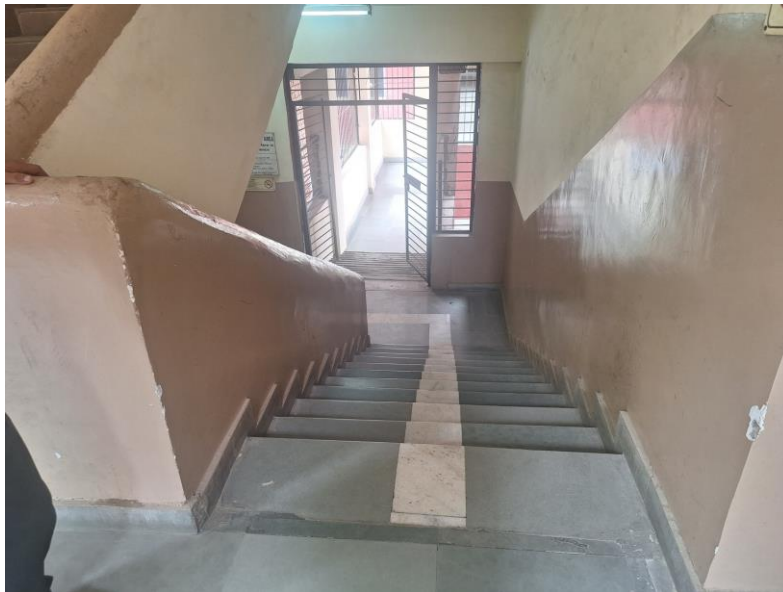
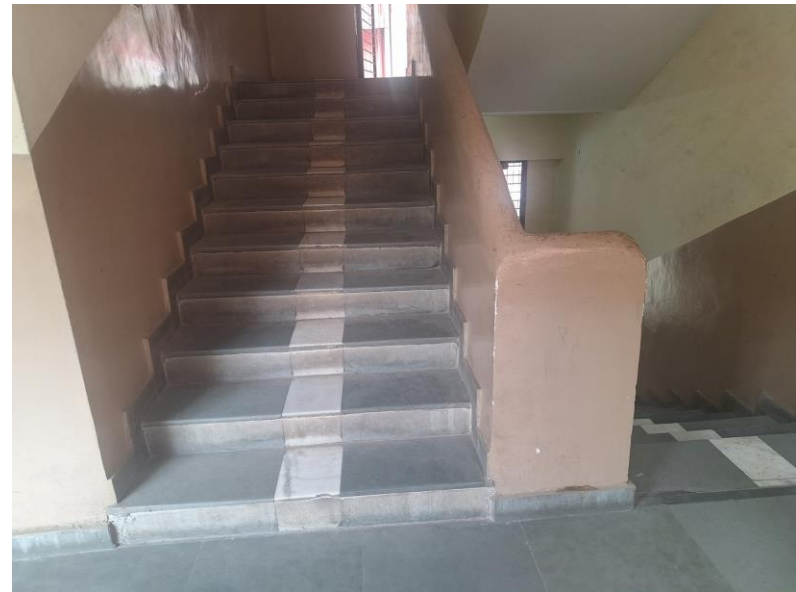
# Staircase (connecting A block and B block)

- TGSi warning is missing in the start and end of the steps including landing of the staircase.
- Handrail is missing on one side of the staircase.
- Extension of handrail on the other side to reach for person with mobility issues from the corridor level with an extension of 300mm is missing.
- Width of the step is 1360mm, height of the handrail on one side is 905mm. First step riser height is 106mm.
- Antiskid edges for each step is missing.
- This is the only access to connect B block in upper floors.
- There is no lift provision in B Block.

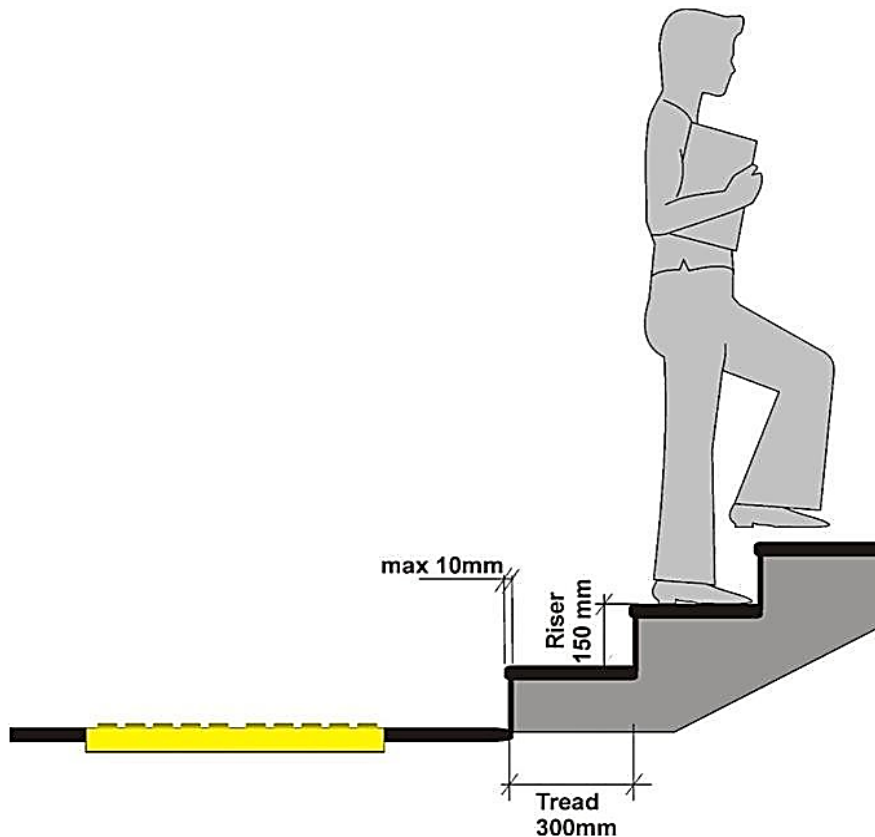
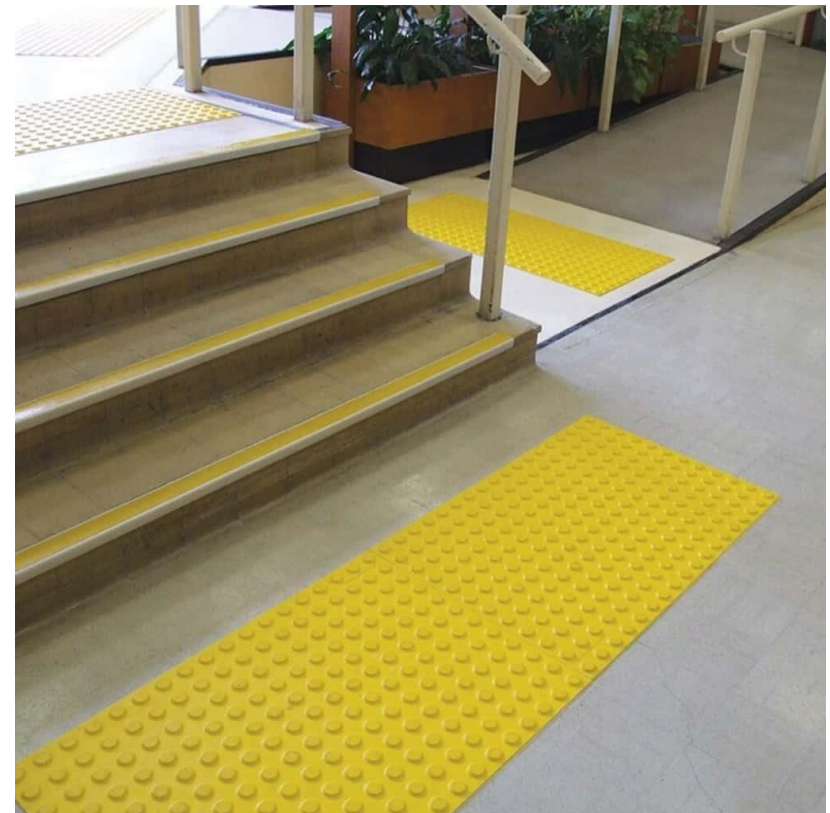
- Specifications for providing tactile pavers and contrast colour strips on the edges of the steps is given in the illustrations- shall be provided for all stairs.

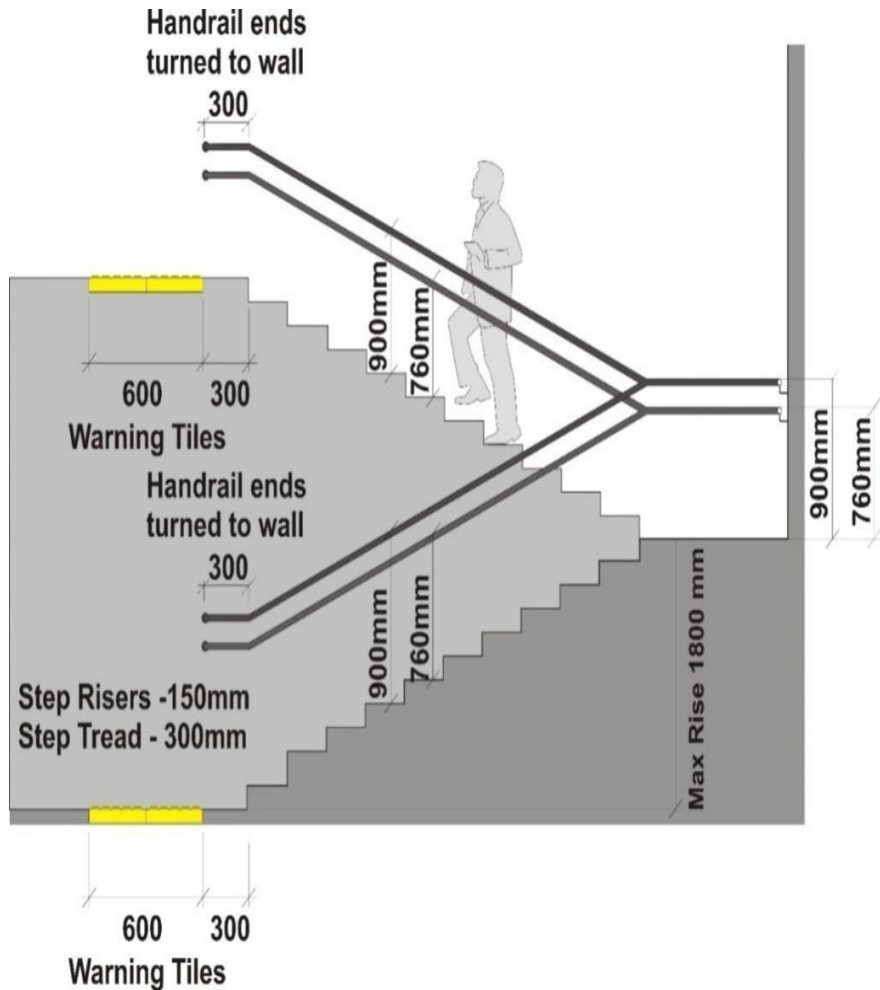
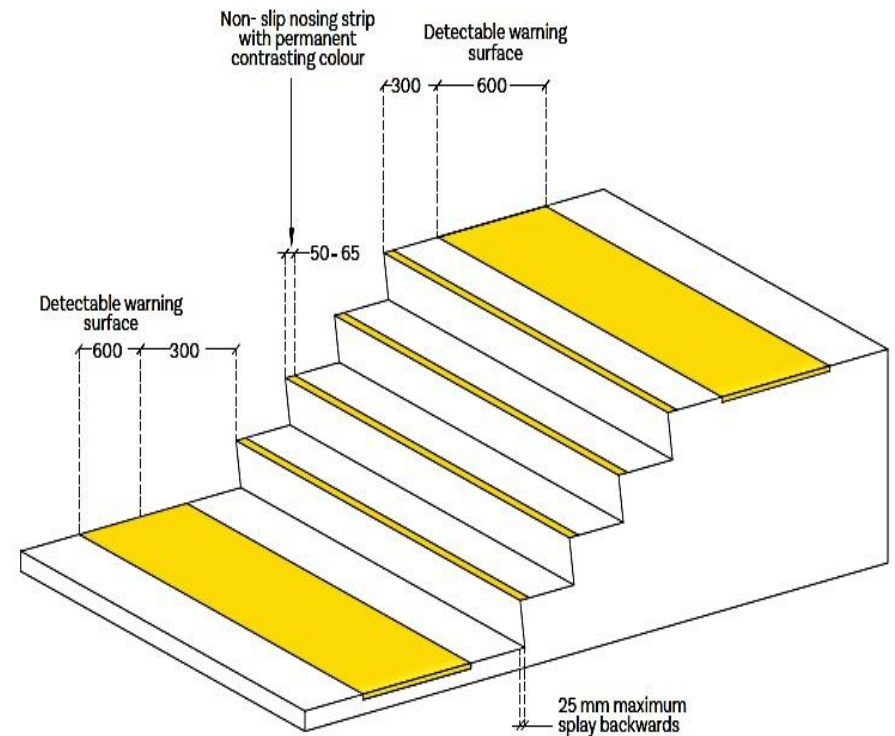
- Provide tactile warning paver as illustrated below.

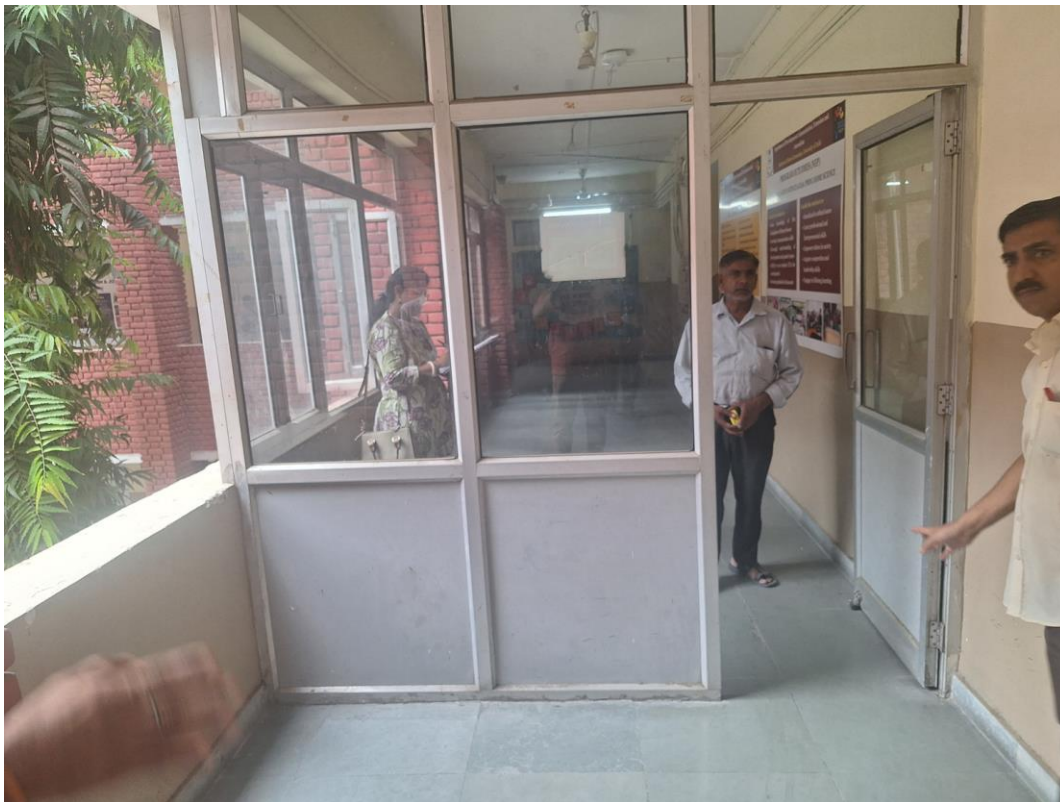
- Doors use heavy glass panels with tight clear openings (720 mm).
- People with low vision will face difficulty whenever they move in this space due to plain glass.
- This space may be created as students common room at every floor level for their discussion.

Ground floor and some rooms in upper floors are accommodated with furniture.  
Picture: Photo of upper floor

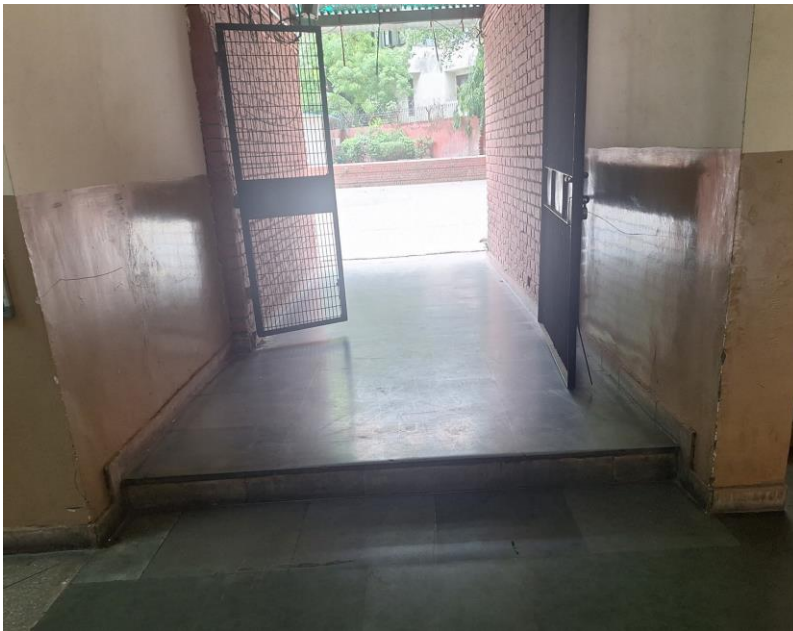
- TGSi warning is missing in the start and end of the step. including landing of the staircase.
- Level difference between the connecting corridor and the basket ball court is 170mm.
- Length of the transition space is 5968mm.
- Width between the wall and the raised platform of the basket ball court is 990mm.
- Ramp shall be provided in the direction indicated in the photo below.

View from the corridor towards basketball court

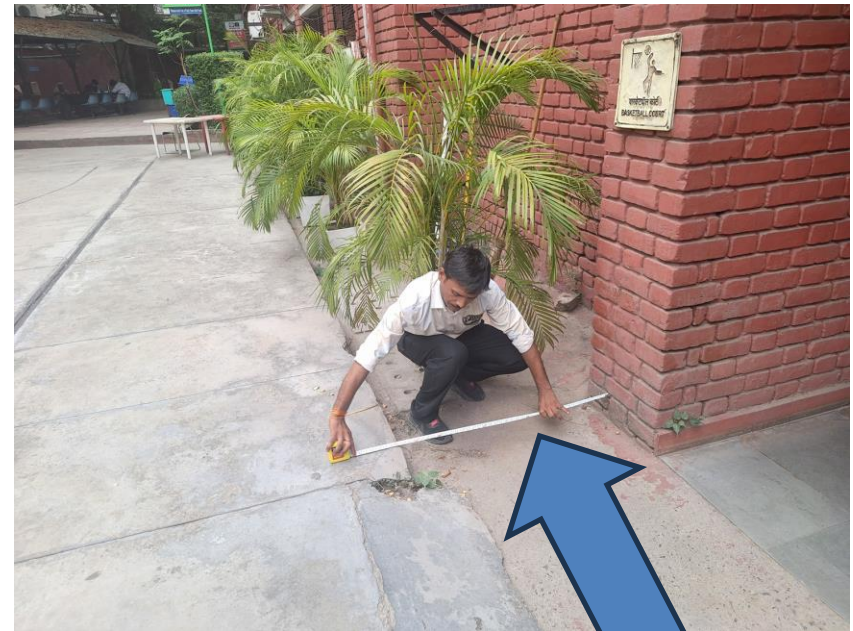
View from the basketball court

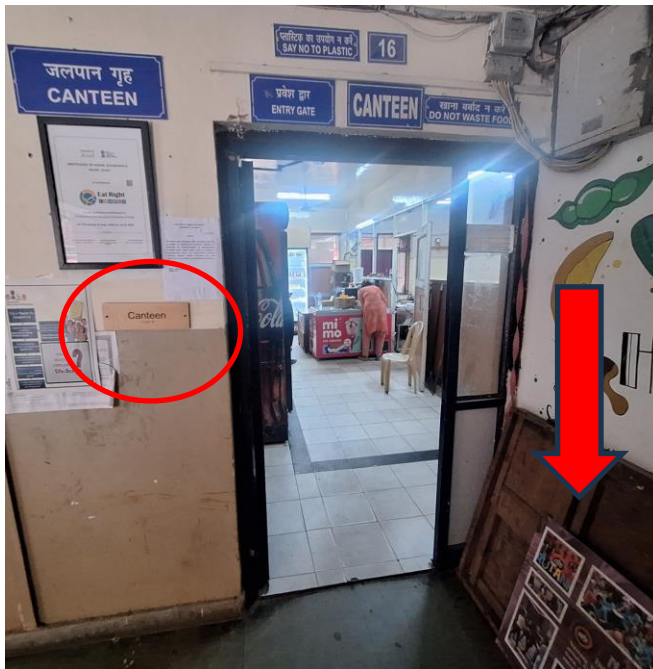
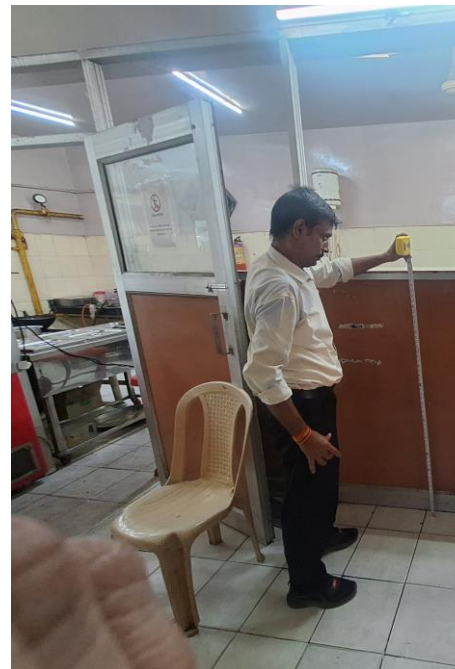
# Canteen and outdoor seating area

- TGSi is missing in front of the door .
- Trip hazard in front of the canteen.
- Doors use heavy glass panels with tight clear openings (720 mm).
- High service counter (720 mm high, 380 mm deep).
- Additional floor level threshold step of +170 mm at the exit connecting the outdoor eating space.
- Pantry is placed directly opposite narrow structural corridors, causing physical bottlenecks when appliance doors or cabinet units are opened.

- Ramp to be provided to merge the gap.
- Refer page no. 38.
- Provide TGSi for connecting are more than 3 m wide.

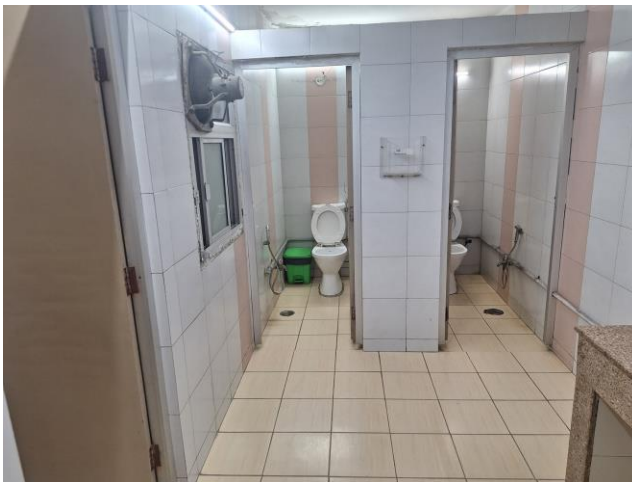
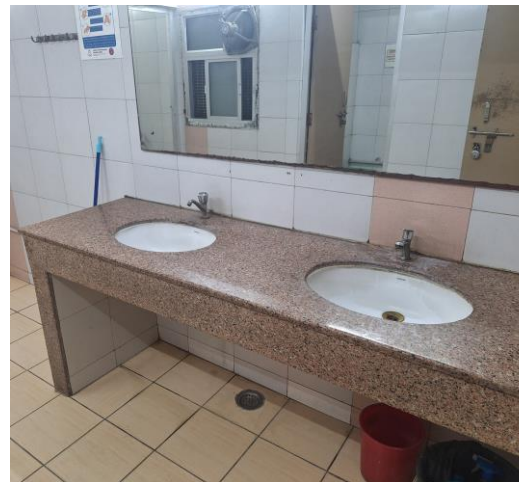
- The size of the **All Gender Toilet** is 1377mm x 3178mm.
- Door opening outside.
- There is no emergency call button inside.
- Grab bars shall be improved.
- There is no washbasin inside the toilet.

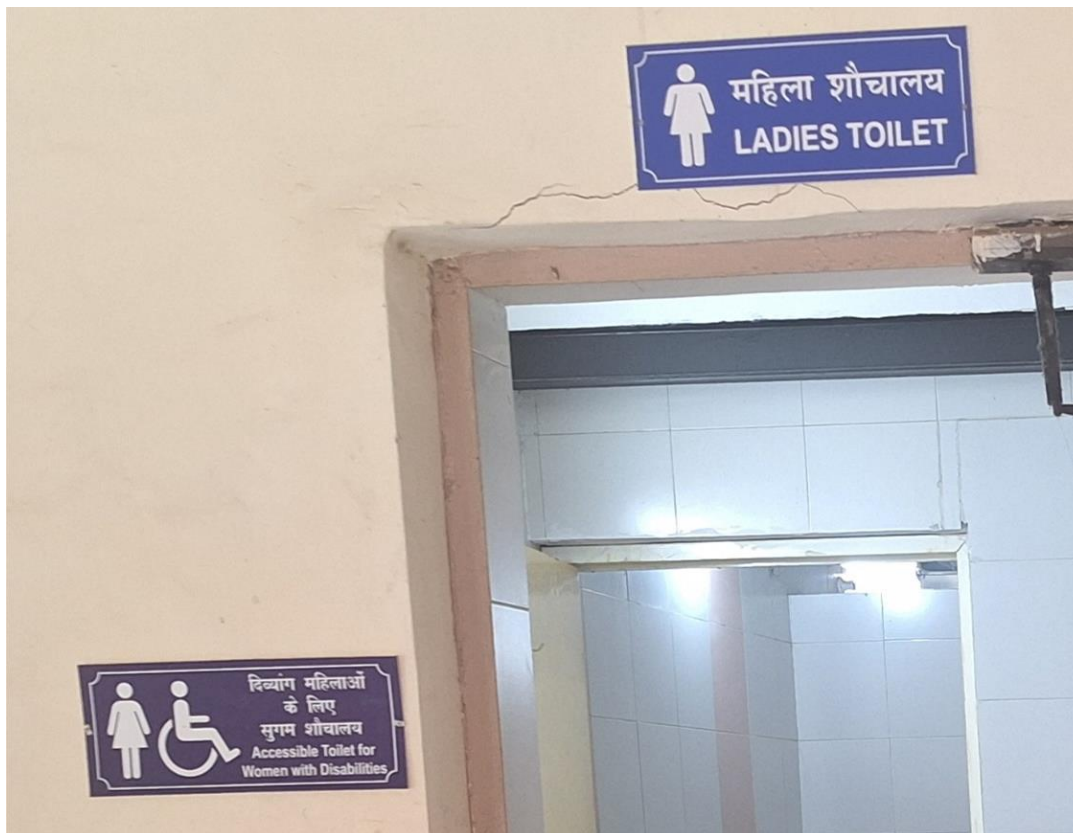
- All Gender Accessible Washroom is provided inside the ladies toilet.
- Braille signage is missing.
- Fixing of signage is at different levels.

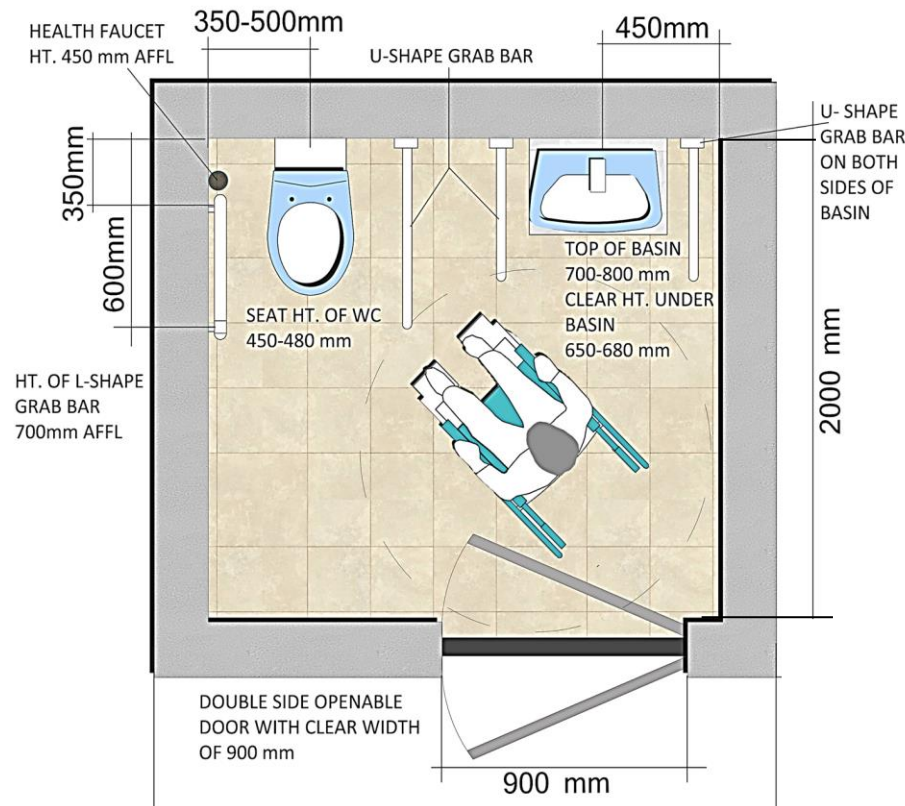
- Size of the accessible washroom shall be 2.3m x 2.2m min. This allows for at least three types of transfers.
- There shall be grab bars – L shape on wall side, U shape moveable on the side of the WC and two moveable grab bars for wash basin
- There should be two alarm switches (near L-shape grab bar) at two levels -300mm and 900mm.
- Peb/hook and shelf for keeping things shall be provided at height between 400mm and 800mm.

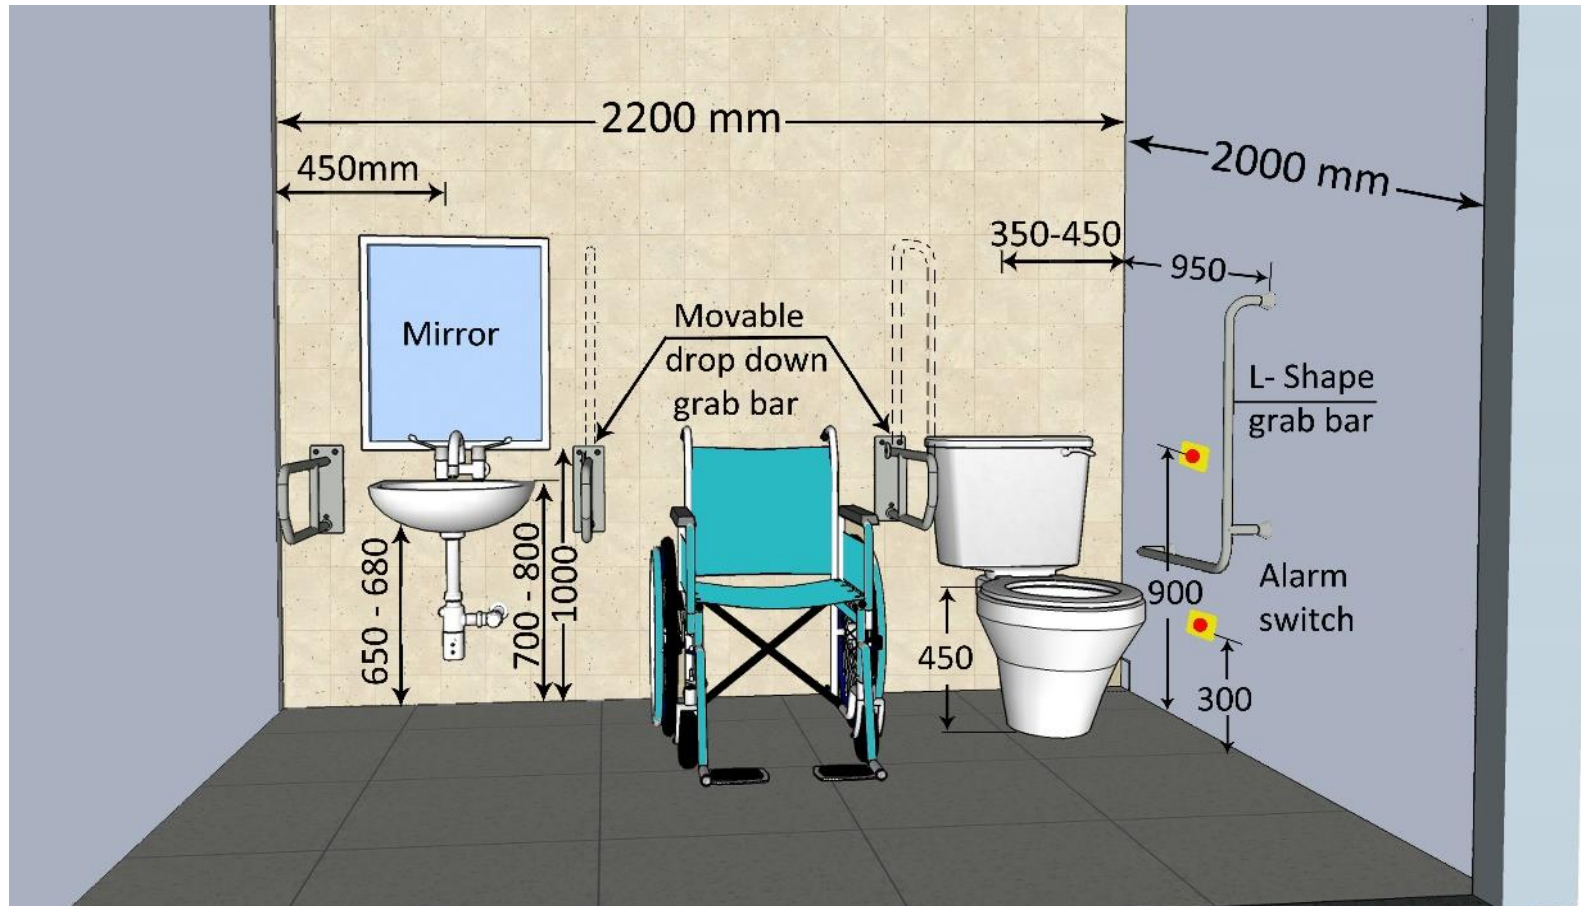
- Specifications of the various hardware and accessories placement for All Gender Washroom are given in the illustration.

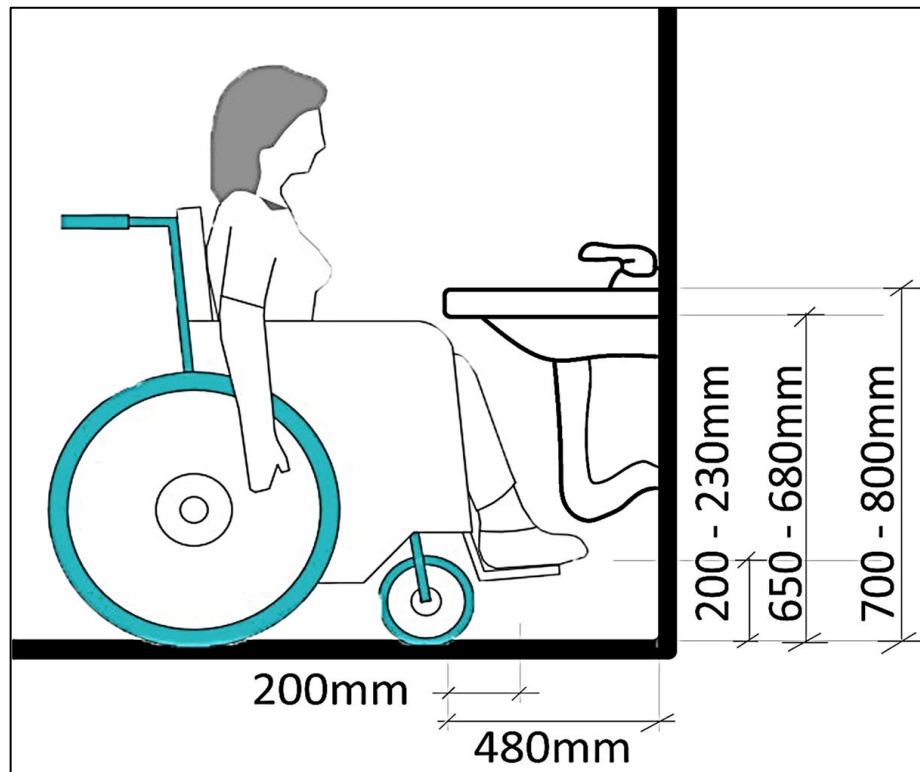
- The dimensions of the washbasin should be 520 mm x 410 mm. When mounted, the top edge should be at a height of 700 mm – 800 mm from the floor, and there should be a knee space of at least 760 mm width x by 200 mm depth x 650 mm – 680 mm height.
- There shall be no pedestal under the wash basin.

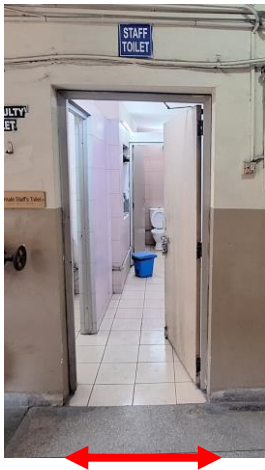
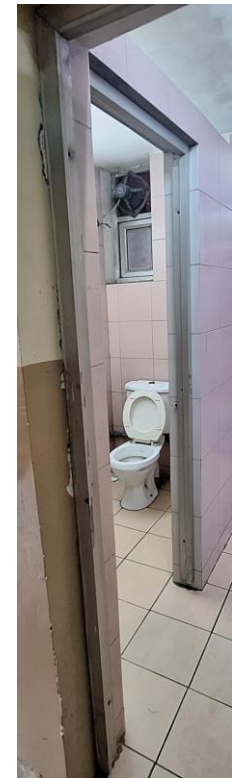
- TGSi is missing in the front of the door with 300mm offset.
- There are 3 cubicles, 1 and 2 cubicle size are same. Third cubicle size is 1057mm x 1964mm.
- One mirror and 2 washbasins are provided.
- **One low level accessible washbasin shall be provided.**

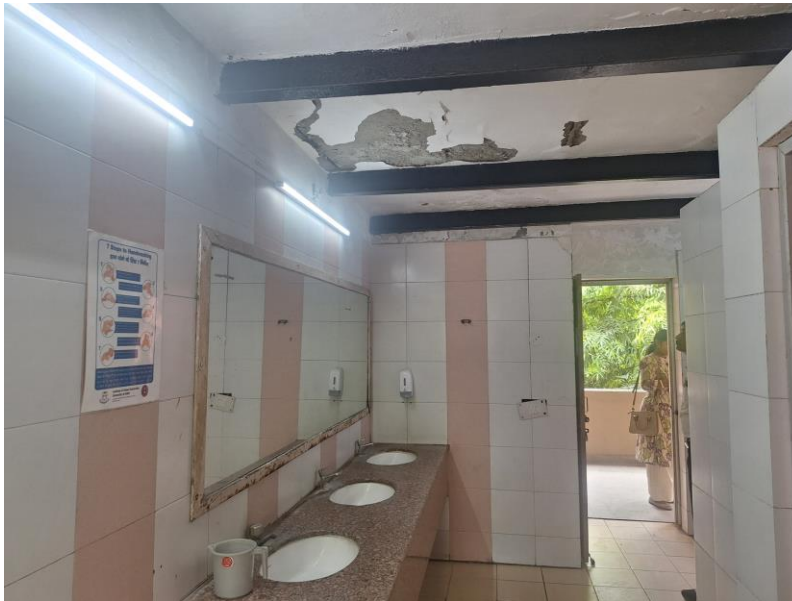
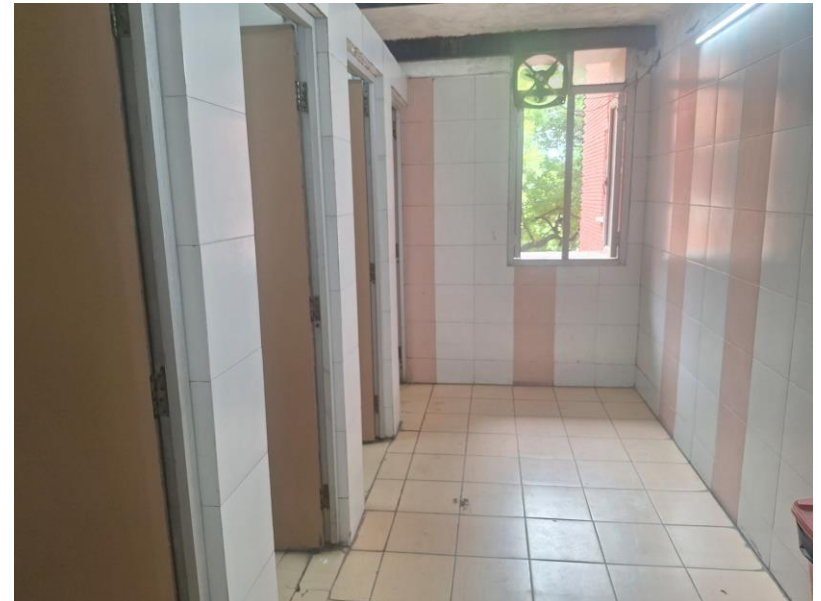
# Ladies Toilet (Second floor) – staff only

- Only 'mirror room' is provided in the space of all gender accessible toilet.
- There are 3 washbasins and 4 cubicles with western closets are provided.
- **One low level accessible washbasin shall be provided.**
- Toilet is in deteriorated stage. Renovation is in progress as per staff information.

- Cubicle 3 and 4 with the space at the front shall be recommended to create All Gender Accessible Toilet.
- Size available is 3326mm x 2102mm.
- One low level accessible washbasin shall be provided.

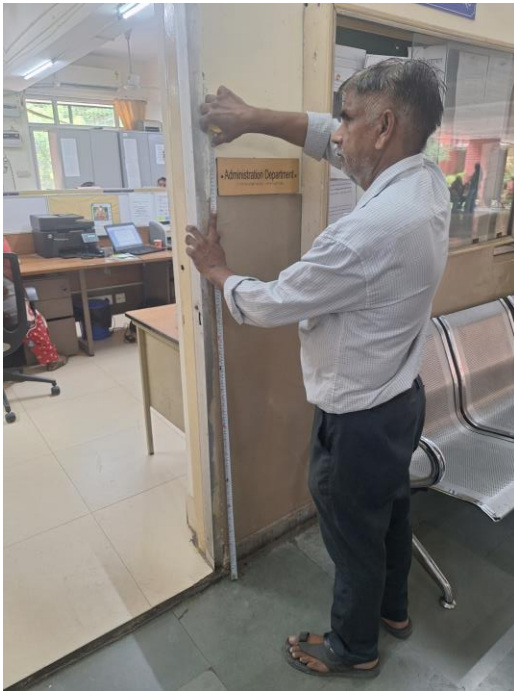
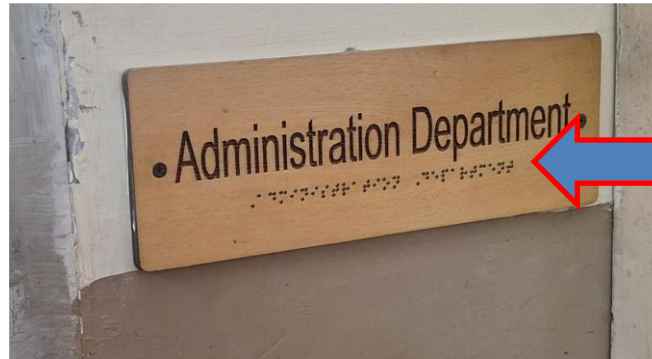
- The height of the Braille in the signage is at 1360mm. There are 2 doors connecting the admin office from corridor space.

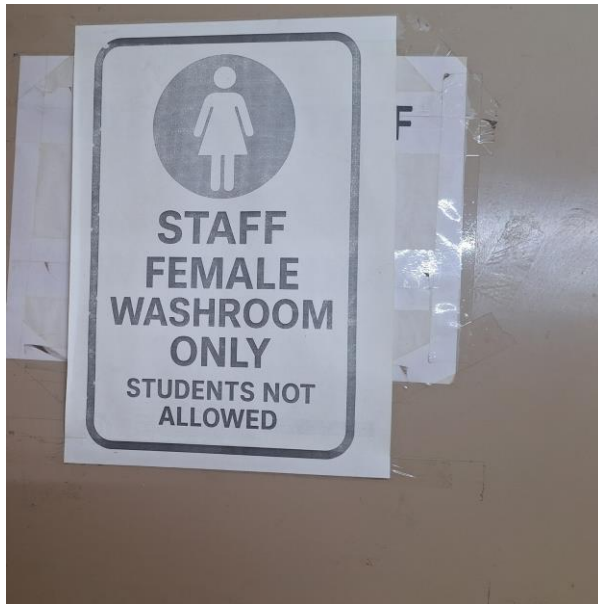
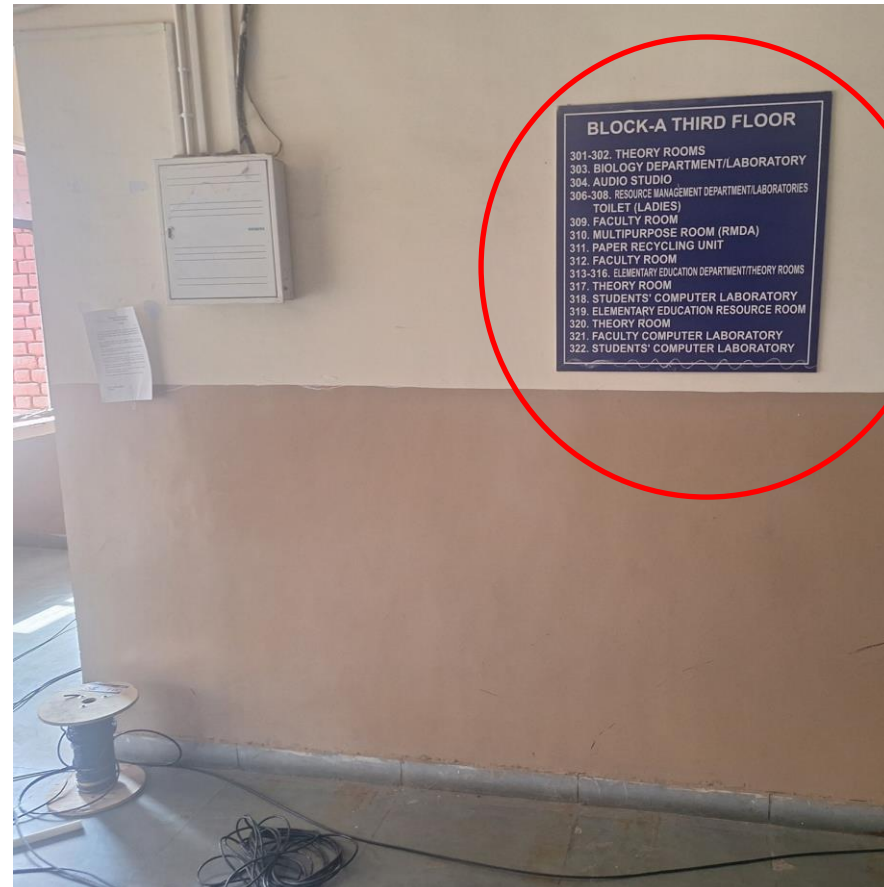
- Signage for ladies toilet shall be improved.
- Waf finding signage with list of rooms is provided in the wall opposite to the lift at third floor.

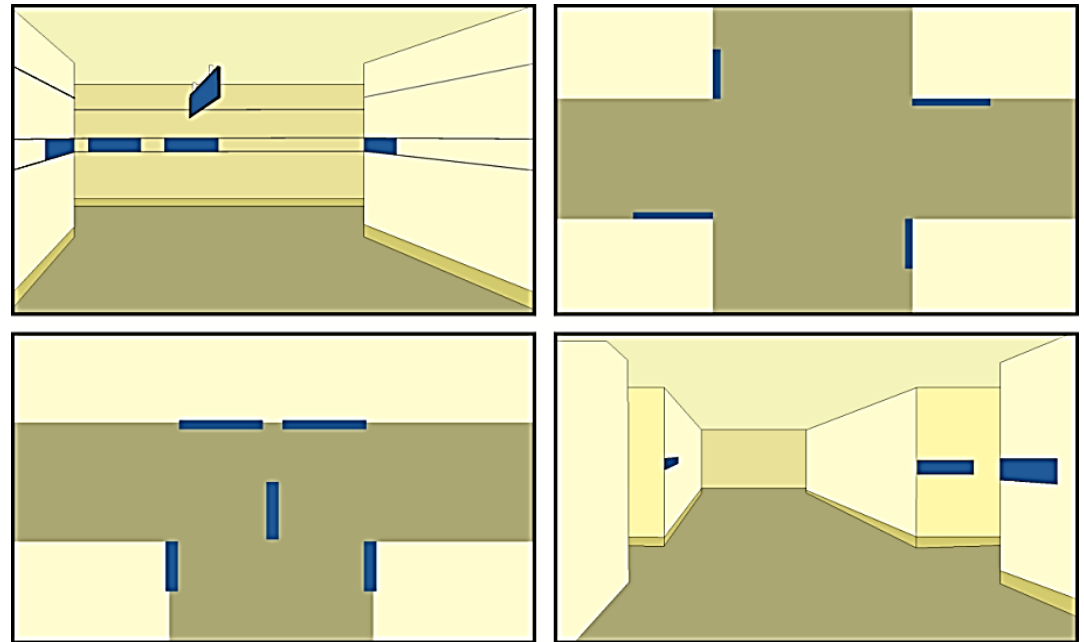
Recommendations - preferred location of signage

- Signage having big fonts, color contrast and well illuminated benefit everyone particularly persons with low vision.
- These should be strategically placed for the maximum visibility as shown in the illustrations.

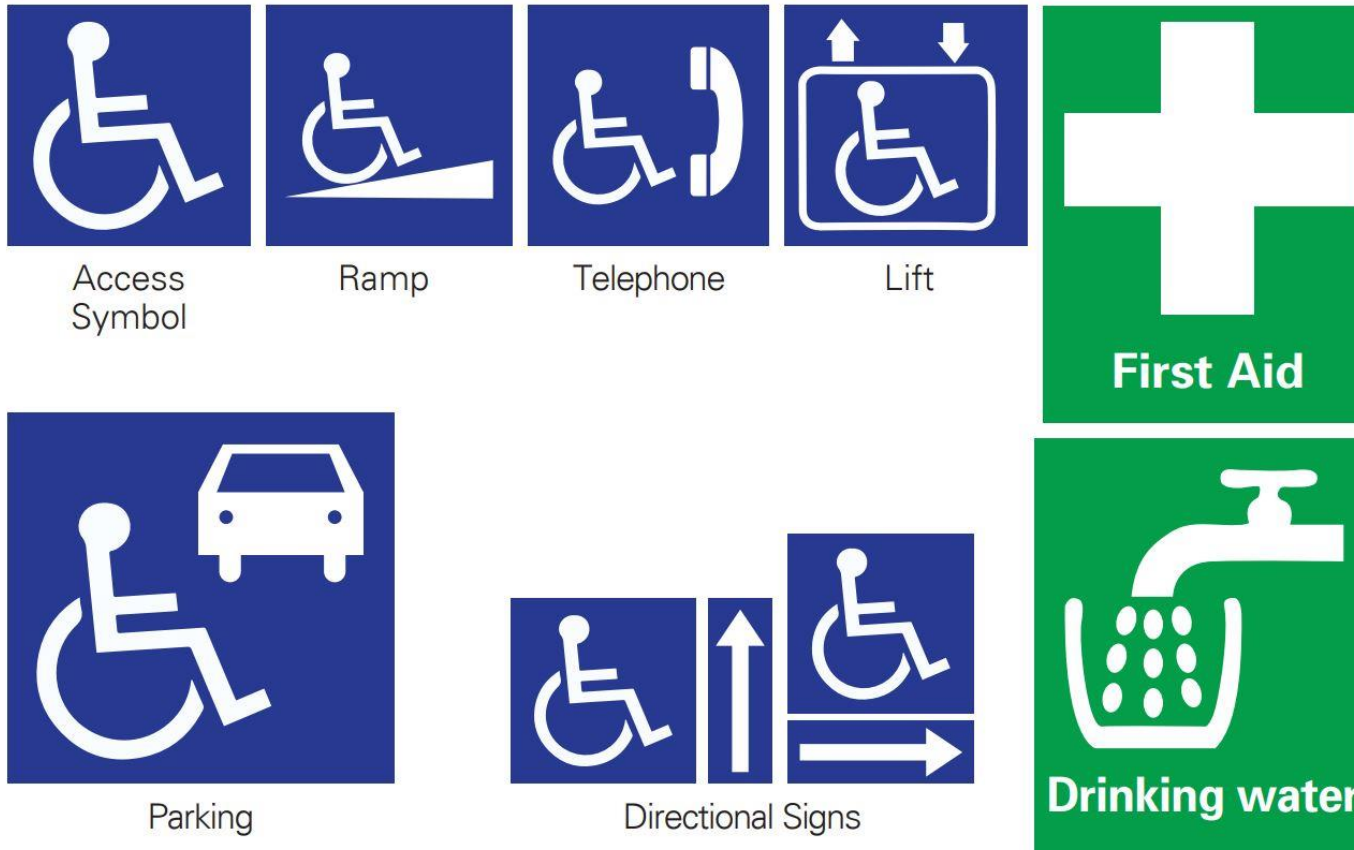
- Block arrows and contrast colour fonts and background colour should be used for signage for accessible facilities.
- All way-finding signage should be strategically located.

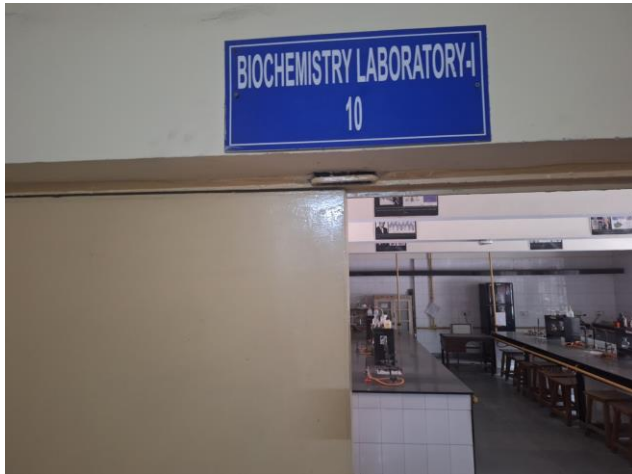
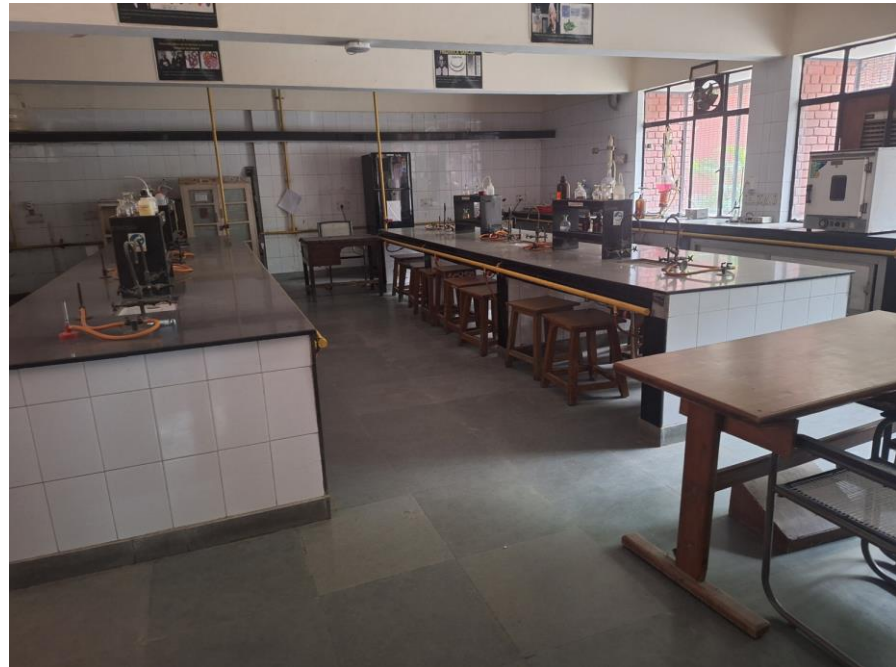
- Standing-height laboratory counters are between 833mm and 851mm.
- No low-level, height-adjustable, or wheelchair-accessible sit-down laboratory sinks or preparation counters are integrated.

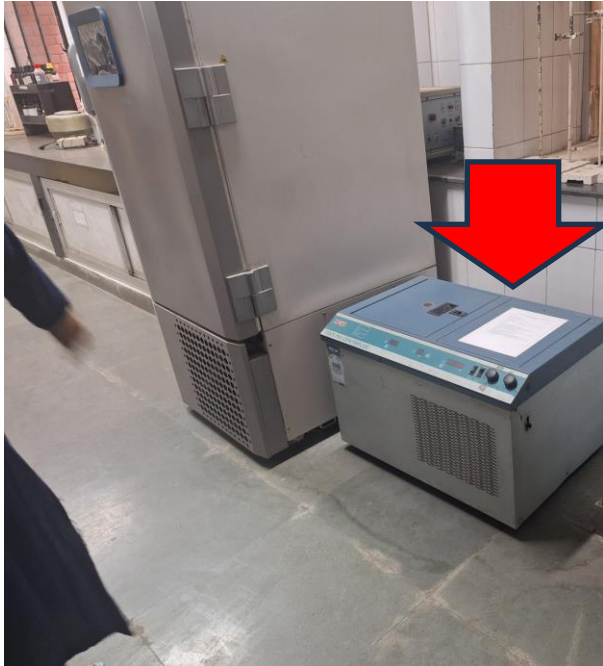
# Biochemistry (Typical 010,110, 210)

- Space recommended for fixing low level sink is indicated below:
- Shifting of this appliance is necessary.

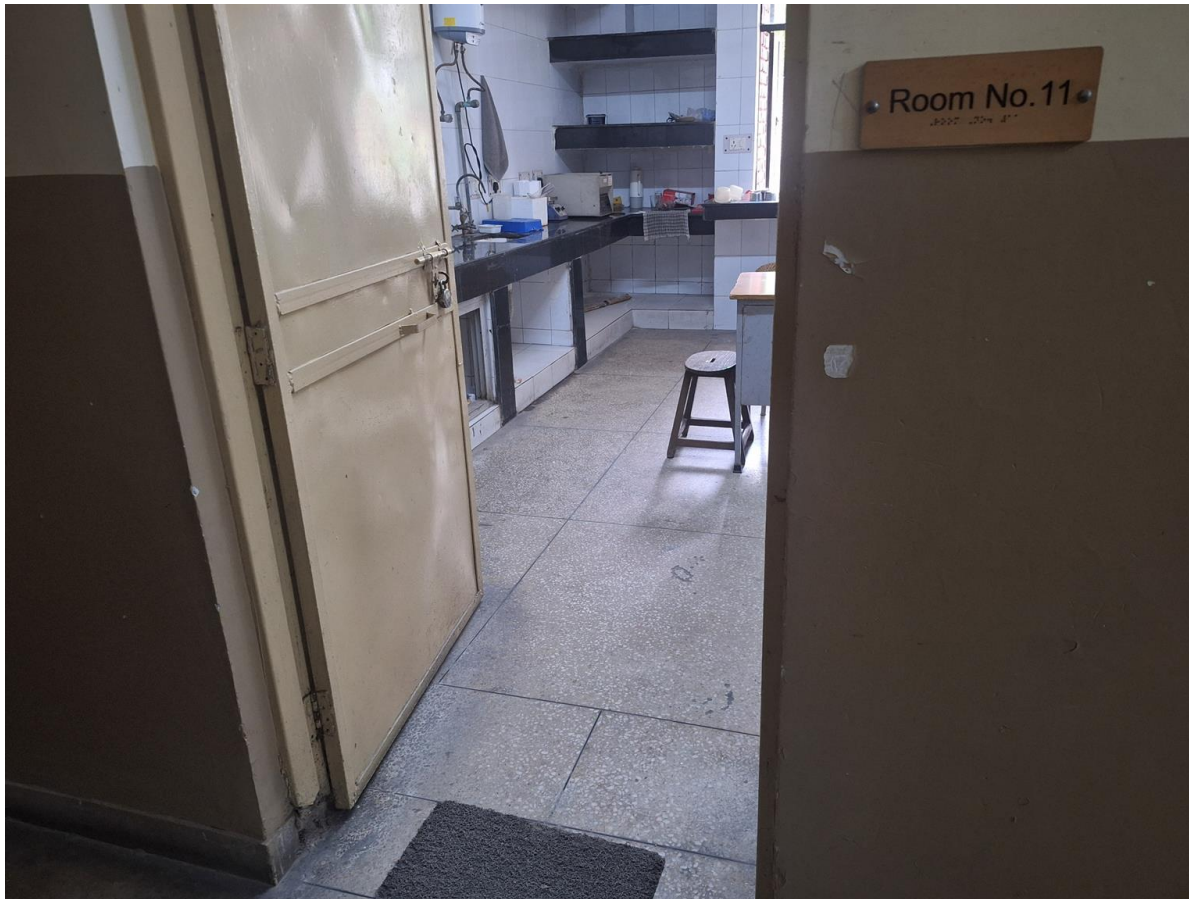
# Preparation Room (only for staff)

- Low level sink or adjustable counter is missing.

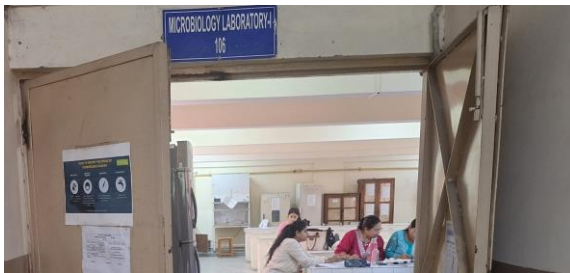
# Micro biology Lab

- Stage/podium is provided for the lecturer. However there is ramp to connect the podium. There is also a space constraints to recommend ramp because the preparation room for the staff is one side of the podium and the entry to the lab on the other side of the podium.
- Low level sink and adjustable counter top shall be provided for person with locomotive disabilities.

Signage fixed at the top of the door

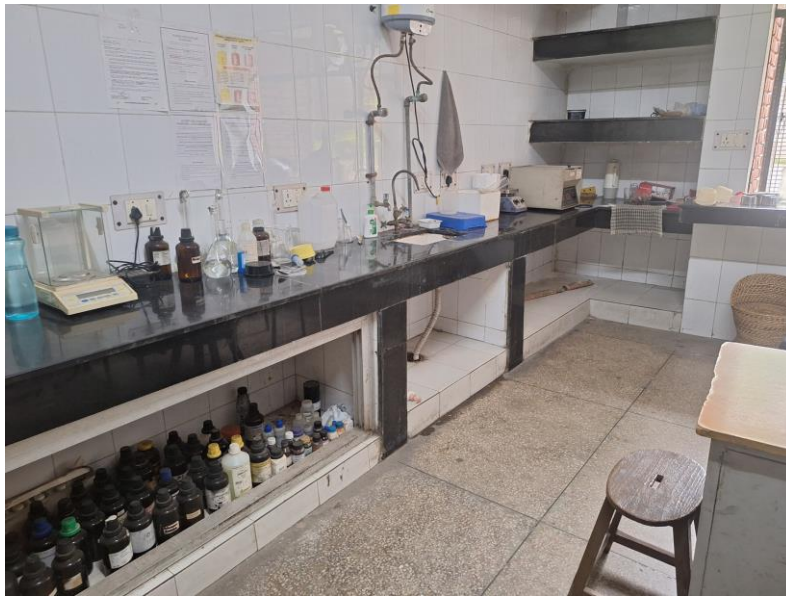
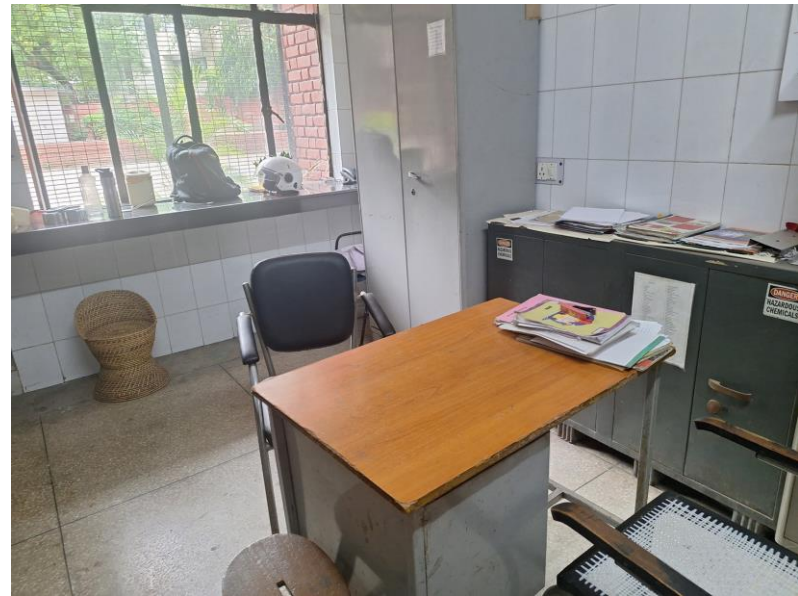
- Stage/podium is provided for the lecturer. However there is no ramp to connect the podium. There is also a space constraints to recommend ramp because the preparation room for the staff is one side of the podium and the entry to the lab on the other side of the podium.
- **Low level sink and adjustable counter top shall be provided for person with locomotor disabilities.**

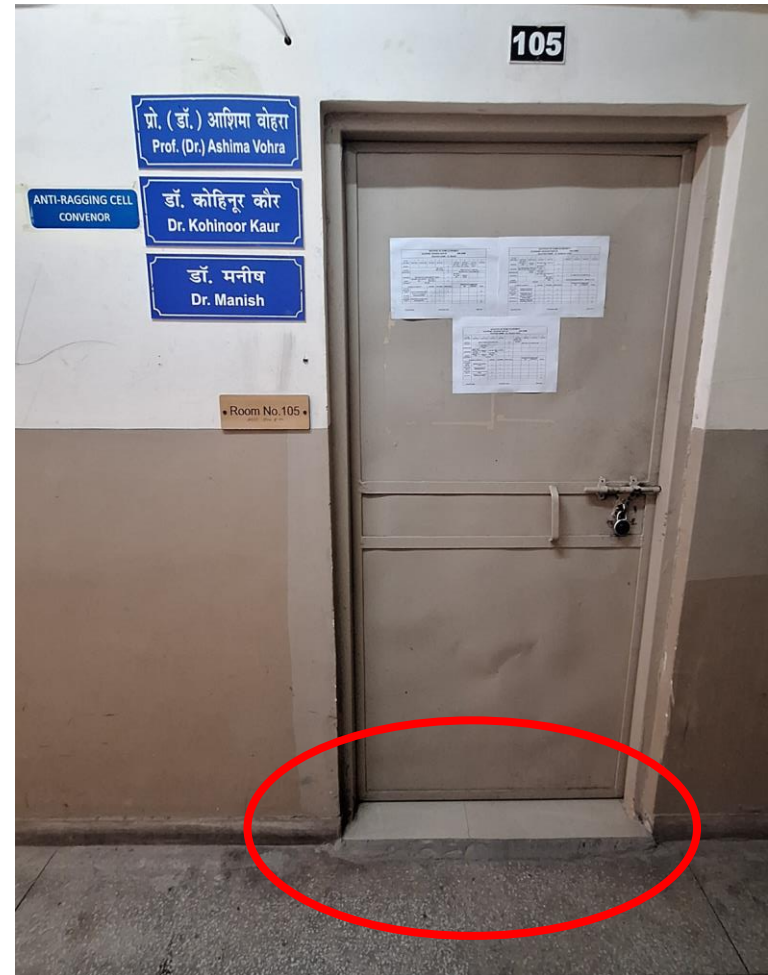
# Anti Ragging Cell

- Door is elevated with 50mm rise from the corridor's finished floor level.
- **Bevelled edge shall be provided to have smooth transition for wheelchair users and people with mobility issues.**

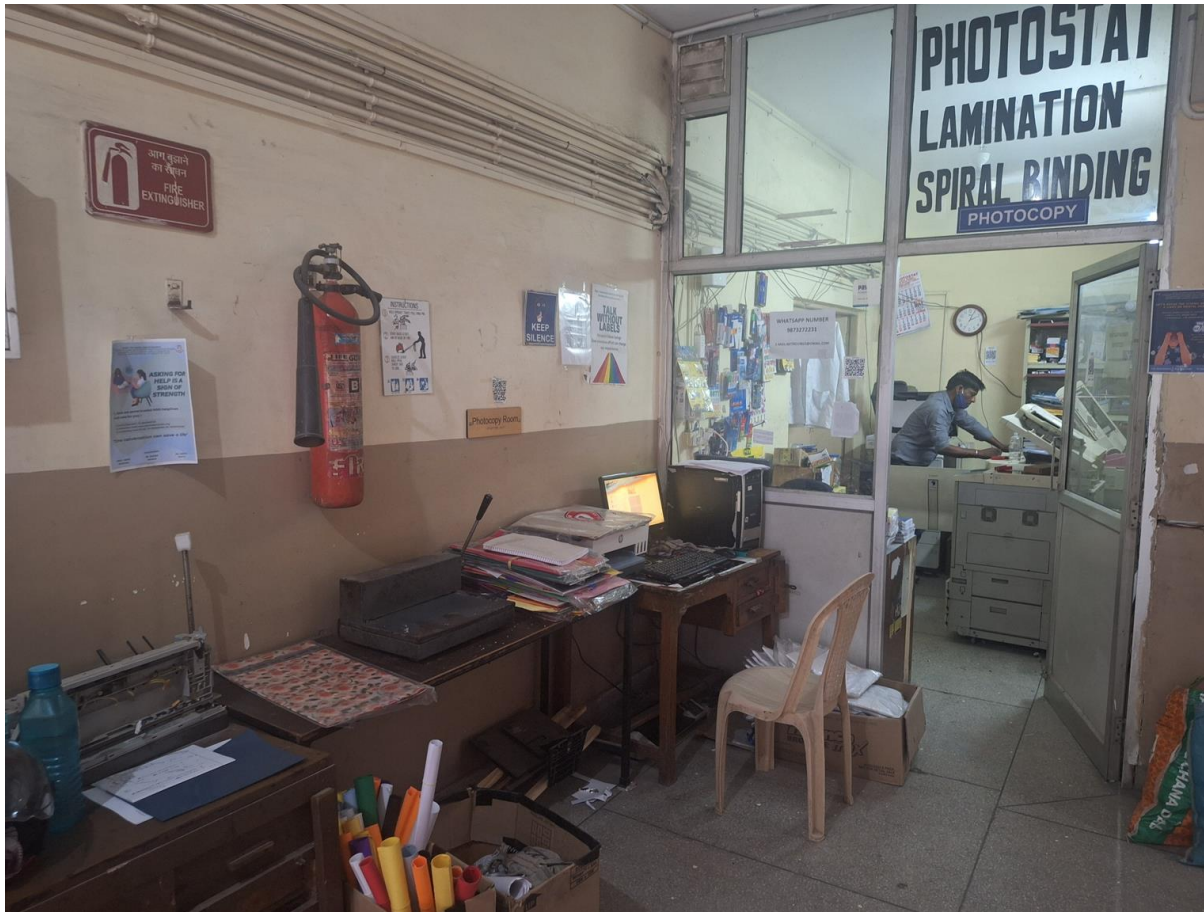
# Printing shop

- Printing shop accessories are extended outside the shop and spread-out in the corridor space.
- **There shall be no obstructions in the accessible path.**
