# Accessibility Audit Report

**Institute of Home Economics**

University of Delhi

1.07.2026

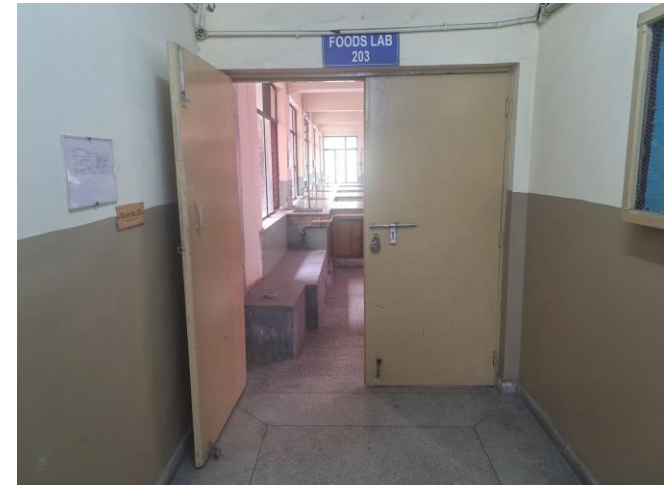
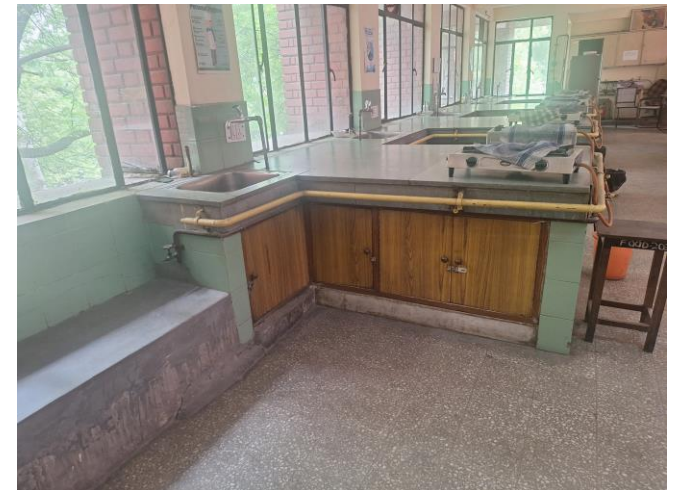
# Food Lab

- **Low level sink and adjustable counter top shall be provided for persons with locomotor disabilities.**
- There are fixed counter and gas bank provided for each student.
- **Low level table for students with locomotive disabilities shall be provided at the rear side due to site constraints with the free standing gas cylinder or induction stove shall be arranged.**

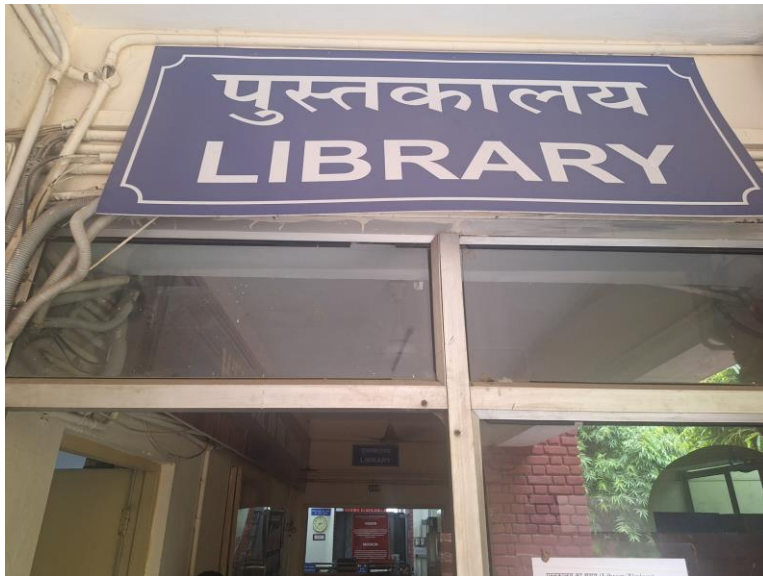
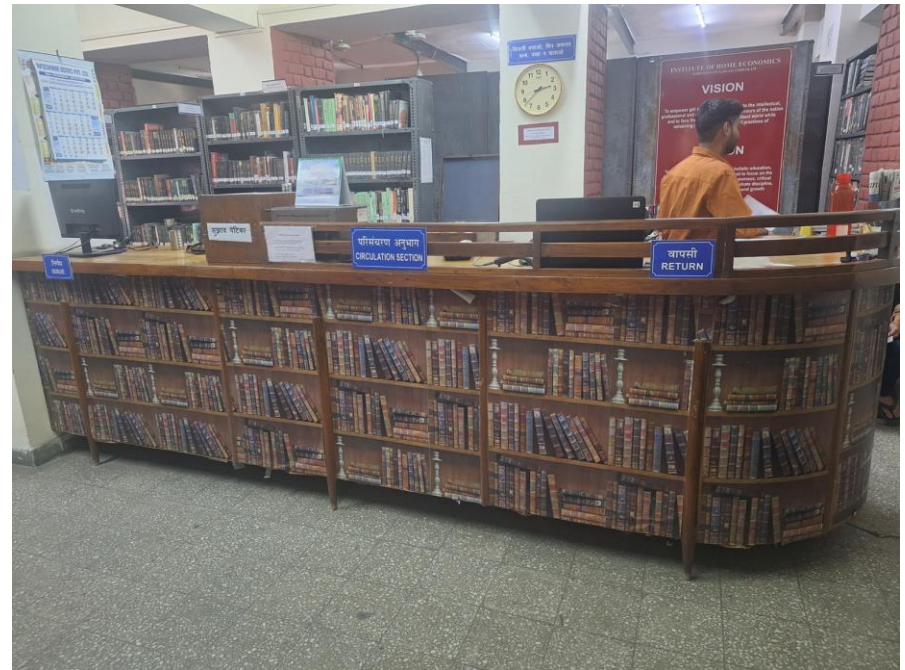
# Library (first and second floor is interconnected)

- The main reception/circulation desk is exceptionally high at 1080 mm.
- Digital space is provided. However, librarian is not aware about screen reader software's and Braille based study materials.
- Counter height is at 1080mm.

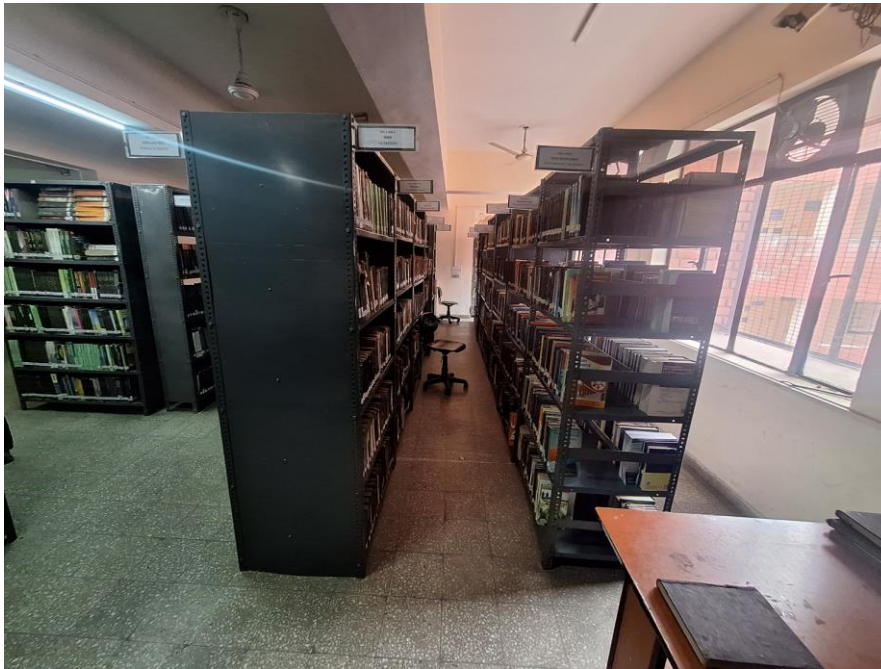
# Library

- Distance between two stack area is minimum of 904mm and maximum of 1367mm.
- Signage for locating books are fixed perpendicular to the passage.

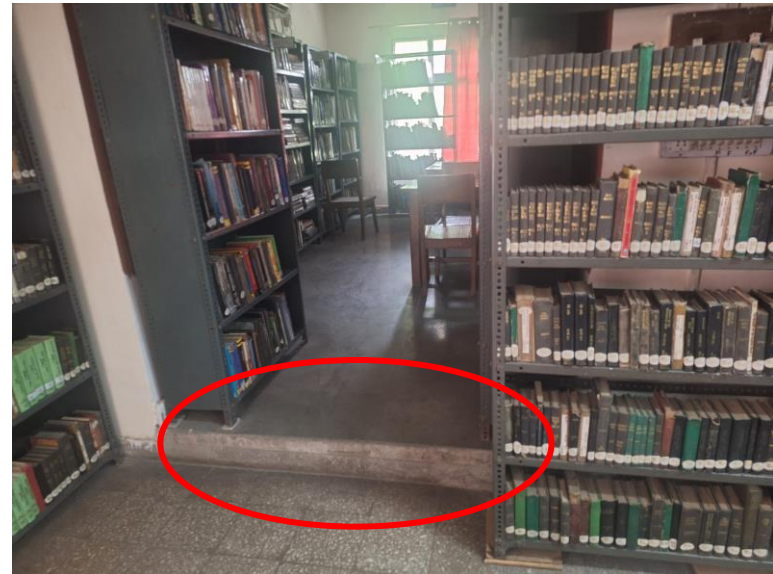
Reserved space for student with disabilities

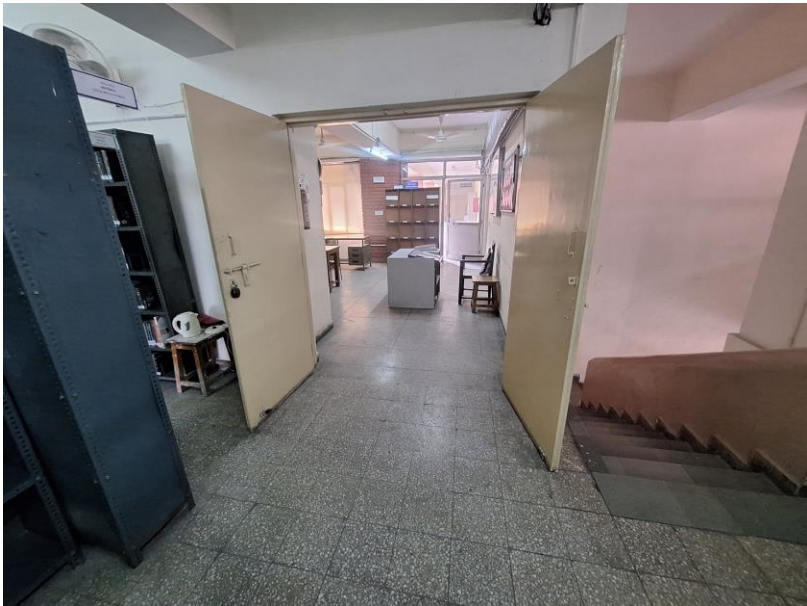
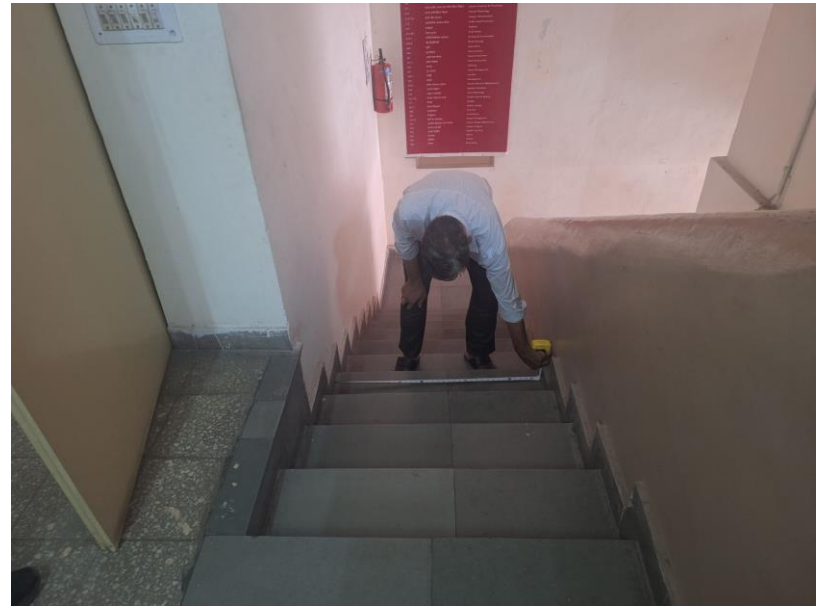
# Staircase connecting Library mezzanine floor

- The mezzanine space is exclusively reachable via a staircase, rendering it entirely inaccessible to mobility-impaired individuals. However reserved space for students with physical disabilities is allocated close to the main entrance of the library at 2<sup>nd</sup> floor.
- The width of the staircase is 950mm, handrail is provided only on one side.
- TGSi warning is missing at the start and end of the step including landing.
- Lighting is not sufficient in the place of staircase area- **adequate illumination shall be provided.**

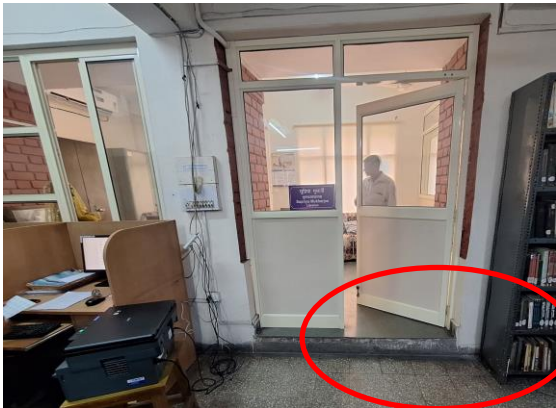
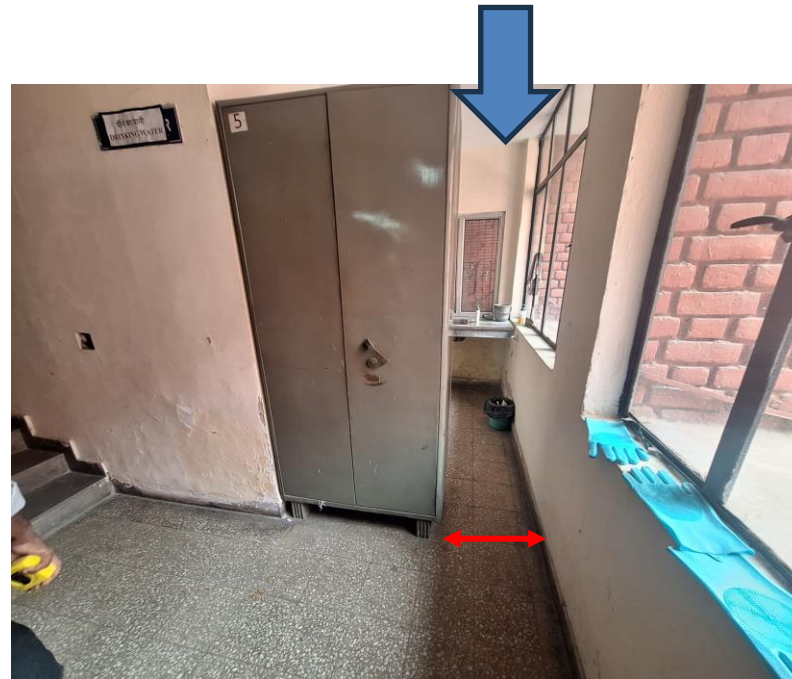
# Staircase connecting Library mezzanine floor

- The main librarian is seated in a room which is elevated from the other library floor space.
- One adjustable counter with clear leg space for wheelchair user shall be provided in the digital lab.
- Space connecting drinking water is narrow due to the stocking of almirah- **almirah shall be relocated.**

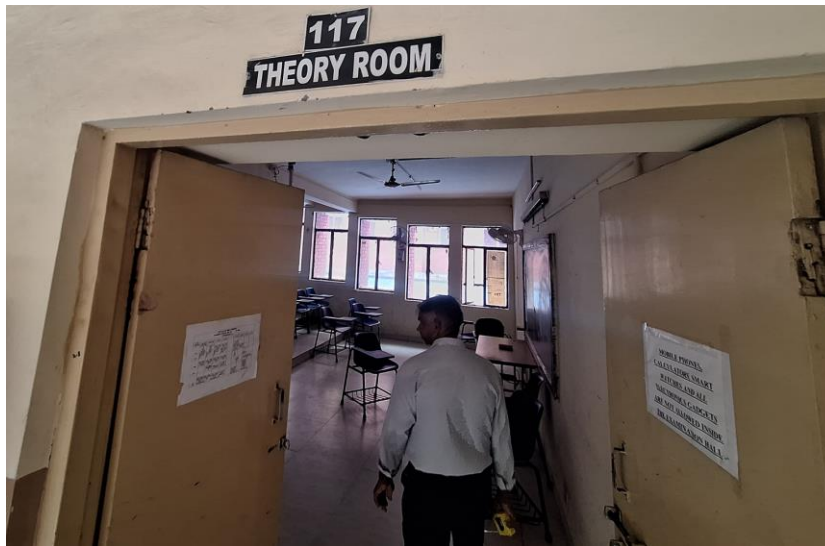
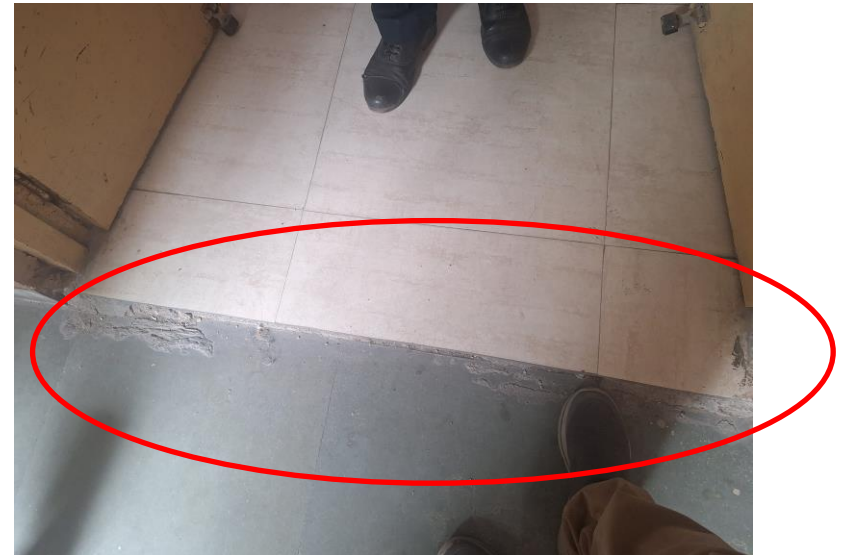
# Theory rooms (Audited room no. 117)

- Door with double shutter is provided to enter the theory room.
- However there is a level difference due to new flooring with ceramic tiles. **Bevelled edge shall be provided to have smooth transition for person using wheelchair.**
- There is no stage/podium for lecturer. Hence, there is enough space to accommodate reserved seating area for wheel chair users in the first row close to the teaching board.
- However, high-level platform/stage access requires traversing 6 steps without an accompanying ramp option.
- There are provision of 2 doors to the theory room. One at the level of the corridor and an another at the last step height inside the theory room with a flight of stairs to exit from the rear side.

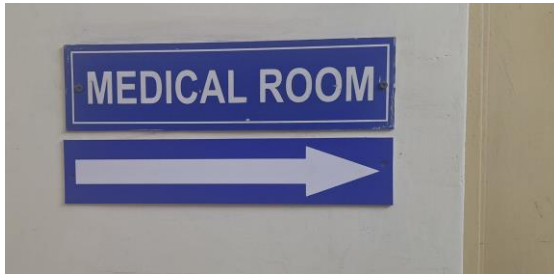
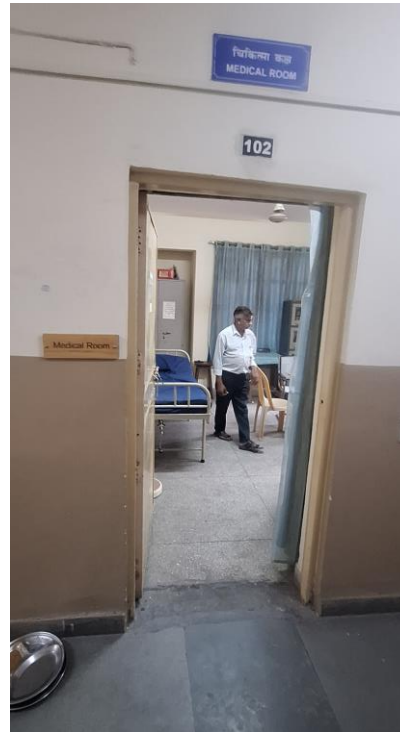
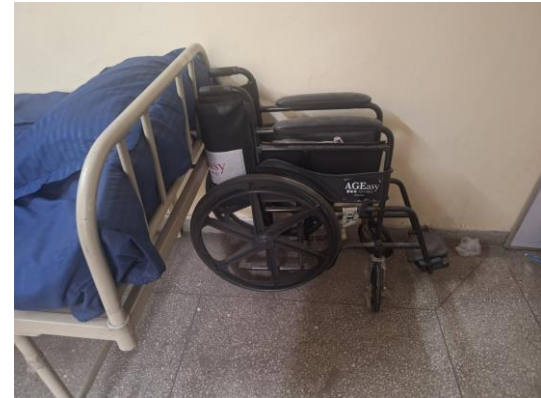
- Signages and way finding system is in place. However TGSi warning is not provided in front of the door with 300mm offset.
- 2 wheelchair is kept inside the medical room.

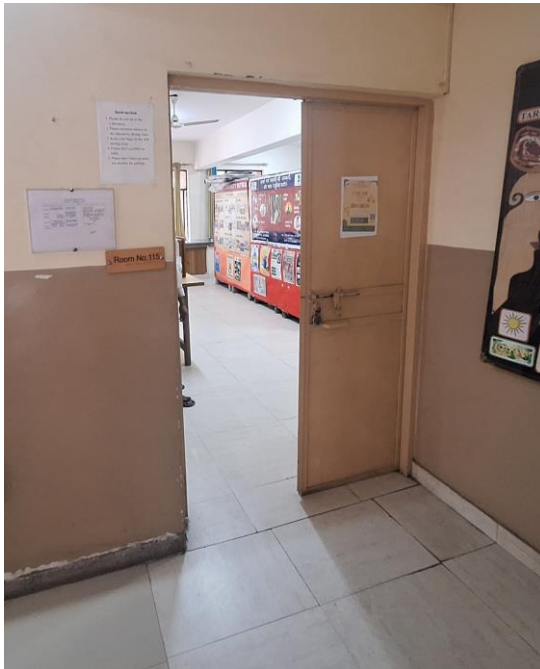
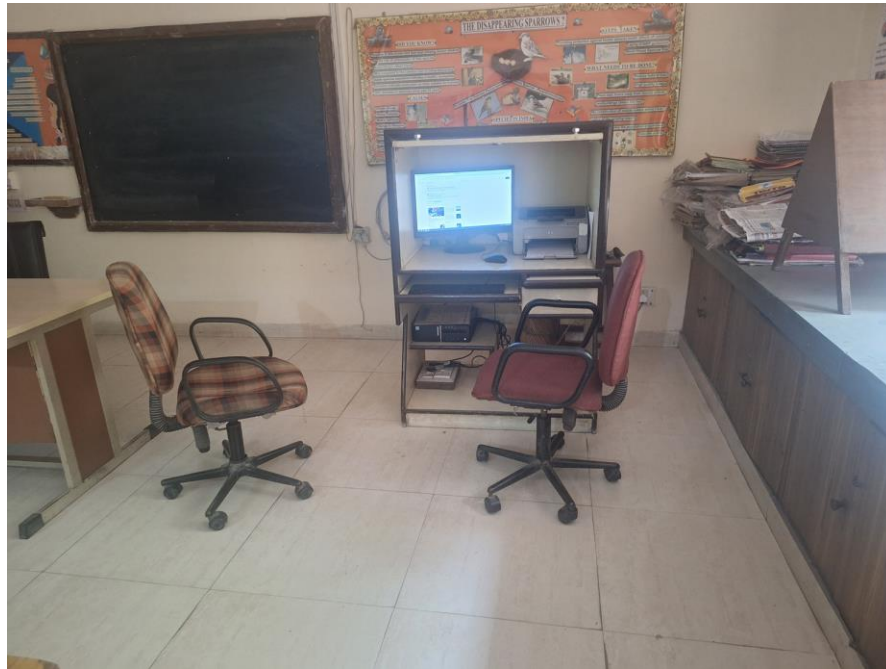
- TGSi, room signage and way finding system is missing - **shall be provided.**

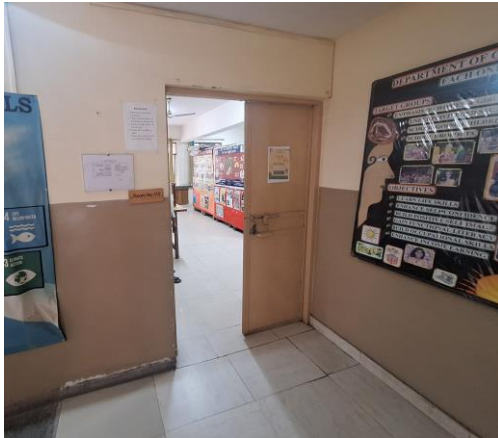
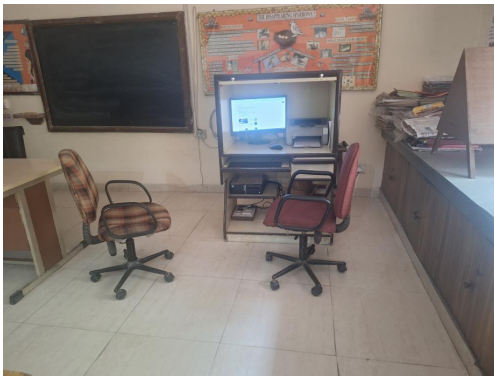
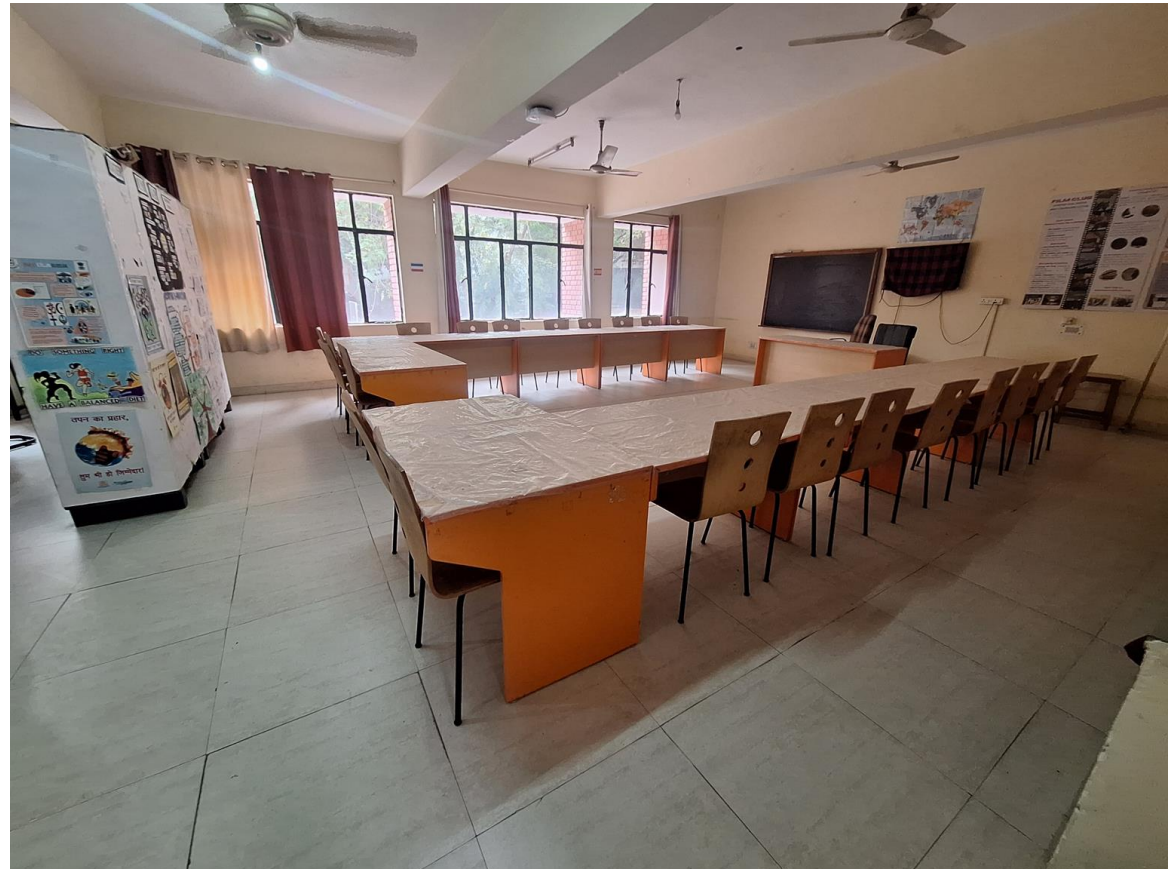
- Signages are missing- **shall be provided.**
- **One adjustable computer table shall be provided.**

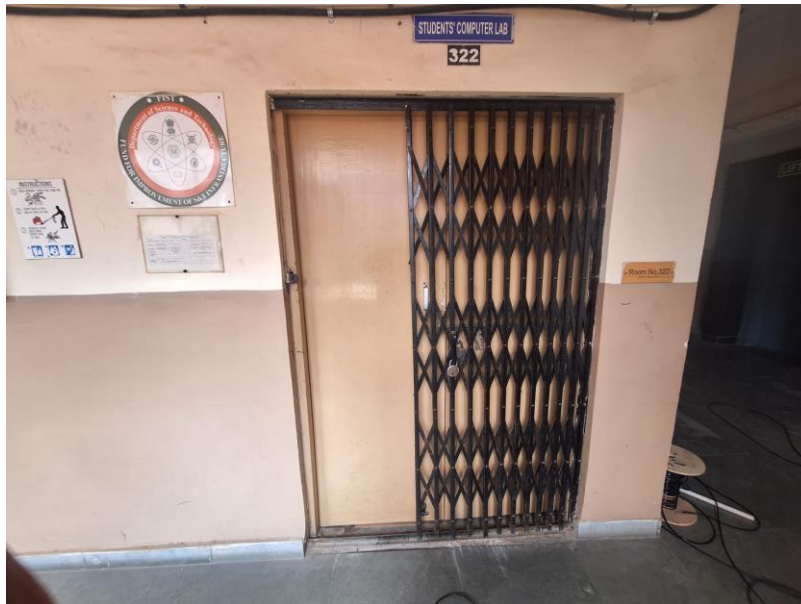
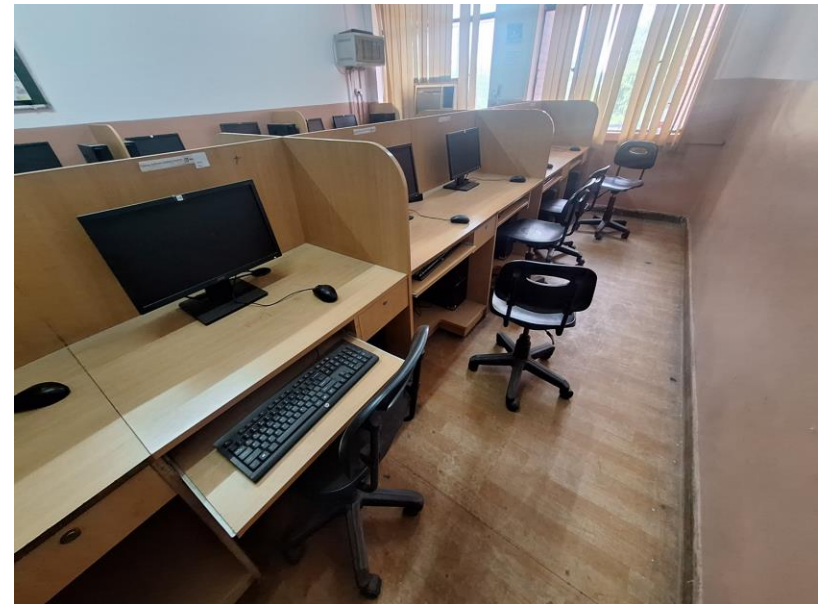
# Students Computer Lab

- Students computer lab is provided with collapsable gate outside and a door with double shutter inside.
- Due to the collapsible gate frame, there is no seamless access to computer lab for wheelchair users.
- One low level adjustable computer lab close to the door with wheelchair turning radius shall be provided.
- There is one huge room locked with old computers in the same floor.

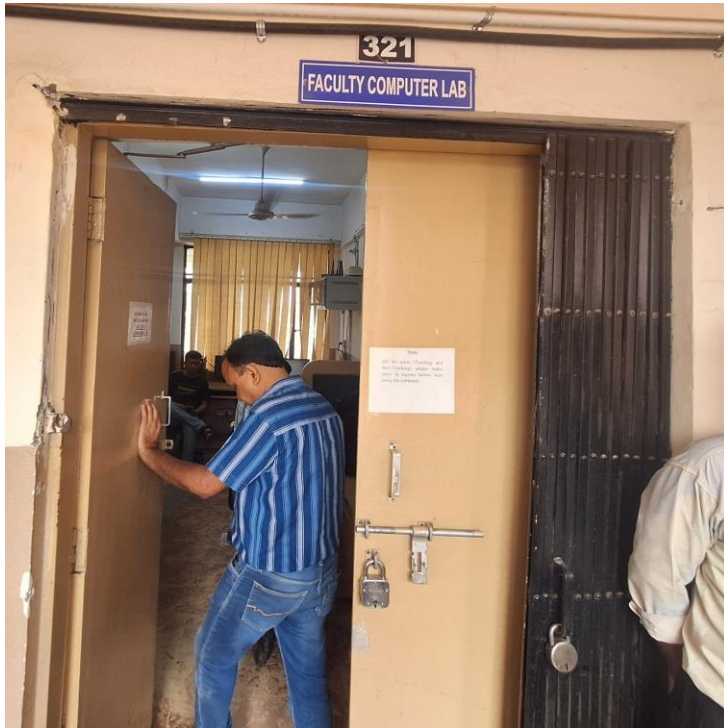
# Faculty Computer Lab

- Faculty computer lab is provided with collapsable gate outside and a door with double shutter inside.
- Due to the collapsible gate frame, there is no seamless access to computer lab for wheelchair users.
- **One low level adjustable computer lab close to the door with wheelchair turning radius shall be provided.**
- **There is one huge room locked with old computers in the same floor.**

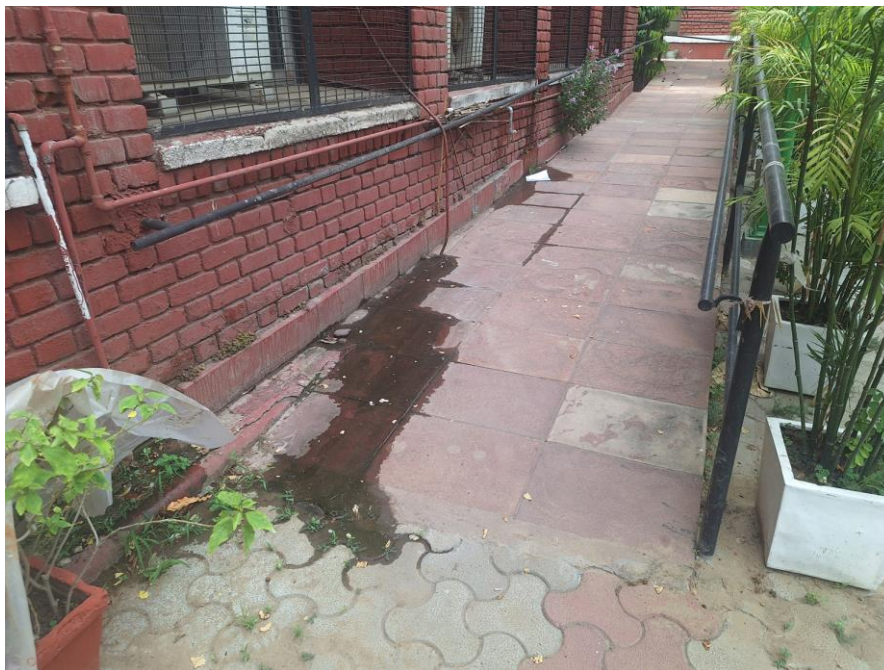
- TGSi warning is missing at the start and end of the ramp including landing.
- Two level handrail on one side and one level handrail on another side is already provided.
- Removal of planters in front of the ramp is essential to avoid hindrance for wheelchair users.
- **Refer page no. 34.**

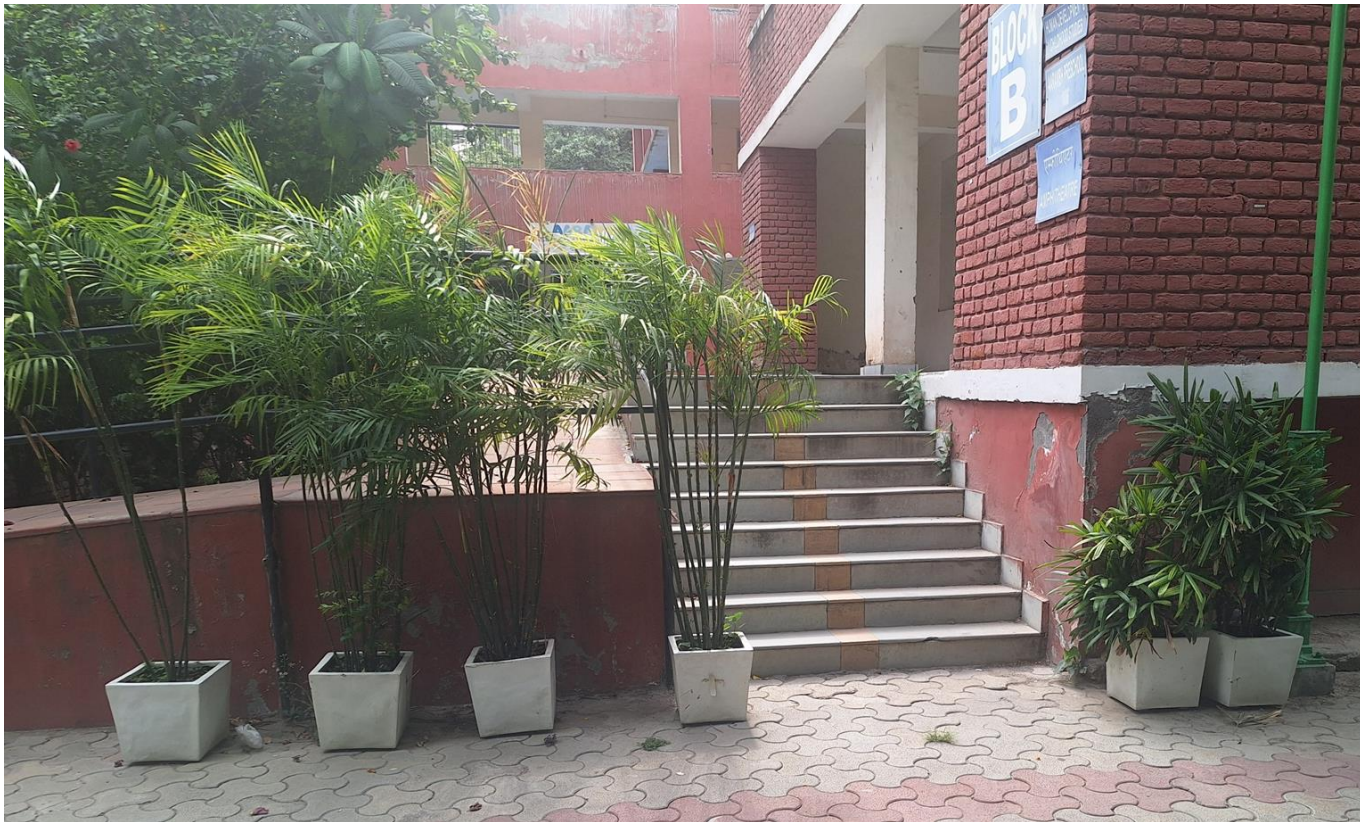
- TGSi is missing at the start and end of the steps.
- Handrail is missing at the either sides of the steps.
- Contrast colour tapes on step edges shall be provided. **Refer page no. 58**

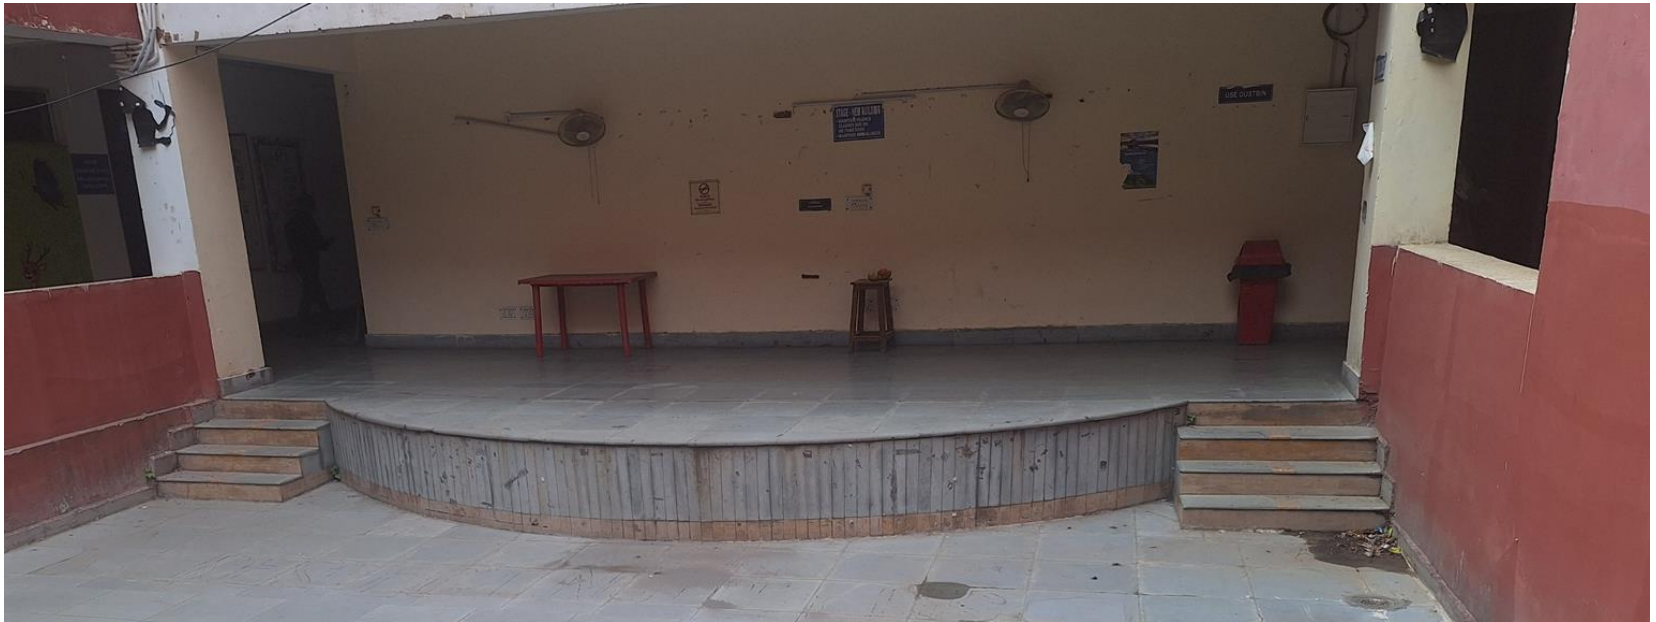
- TGSi warning is missing at the steps (start and end of the steps)
- Ramp shall be provided by replacing the steps on one side.
- **Refer page 34 and 58.**

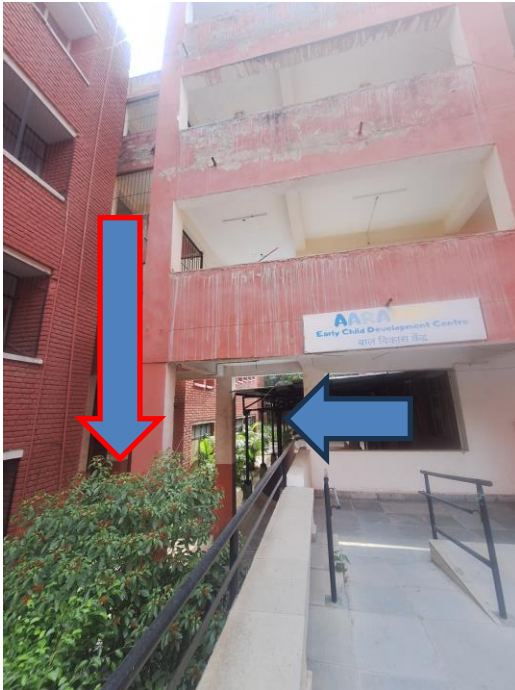
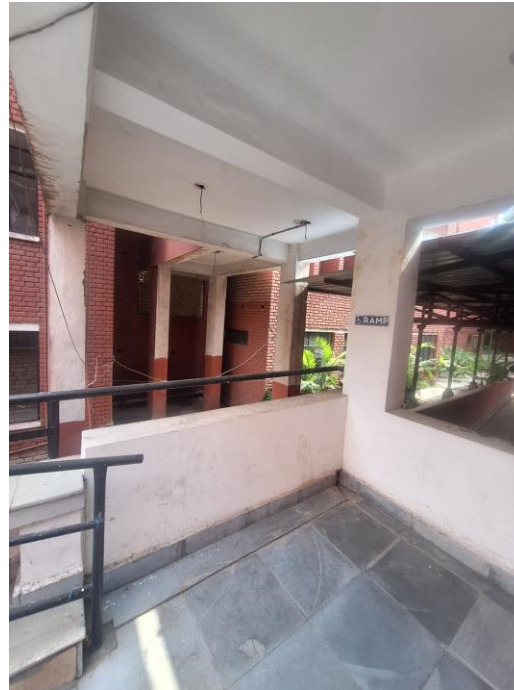
# Recommendations for Lift (connecting A & Block) location

- Space highlighted is suitable to provide new lift.
- This area has a connection at all floor level.
- This is also close to the connecting staircase between A & B block.
- **Refer page no.**

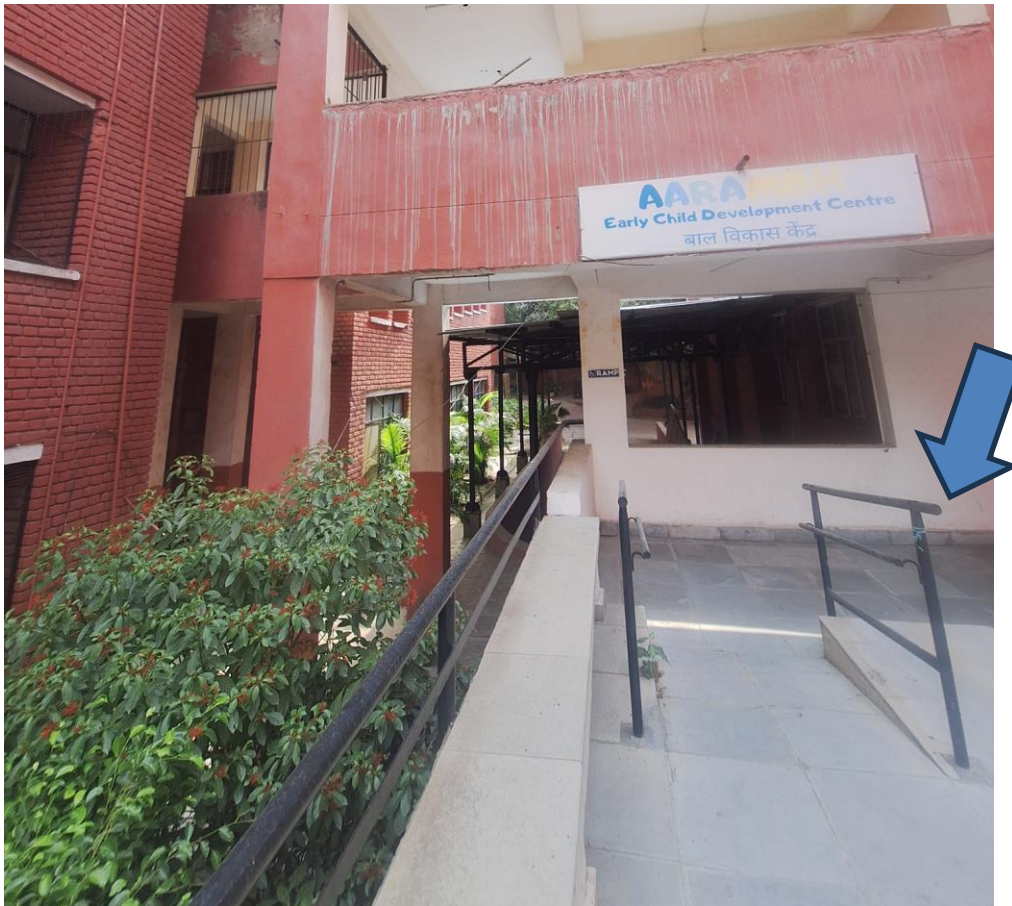
# Ramp connecting corridor

- The length of the ramp is 1500mm, width of the ramp is 1100mm, and the plinth height is +370mm.
- **Provide ramp as per page no.**

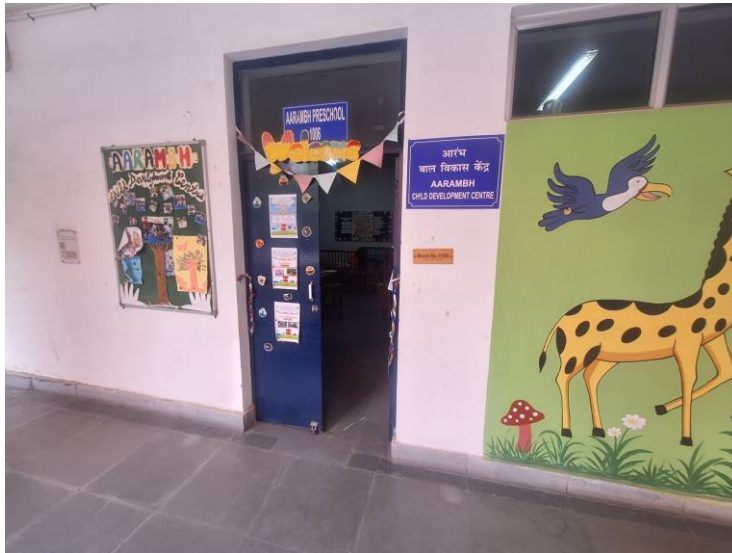
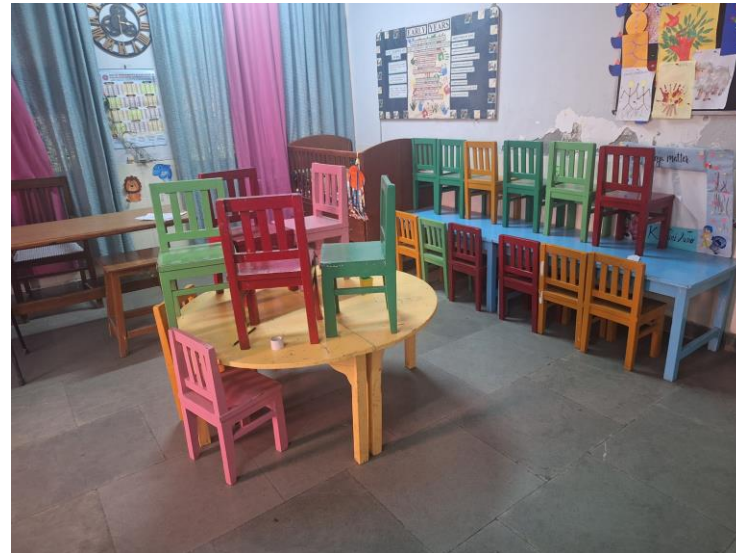
# Day care

- The multipurpose hall is very spacious.
- However, the therapy room is small and it is used as storage space.

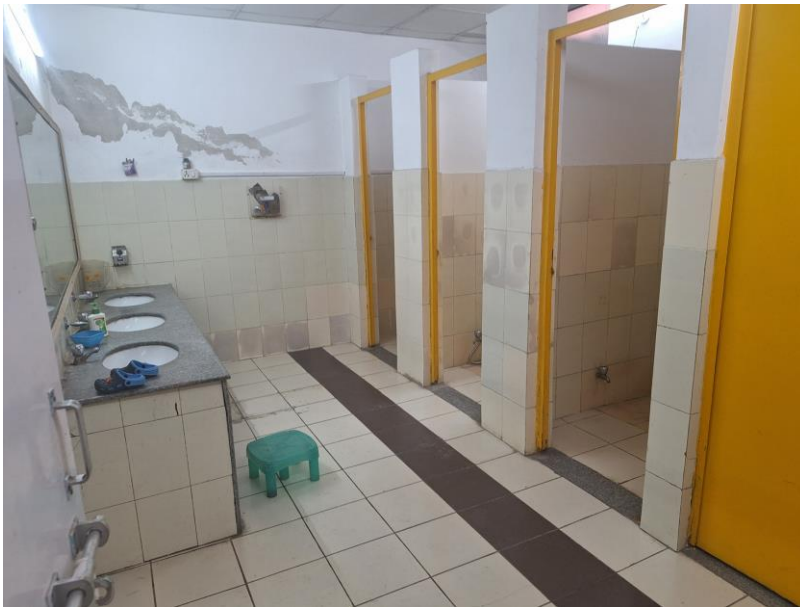
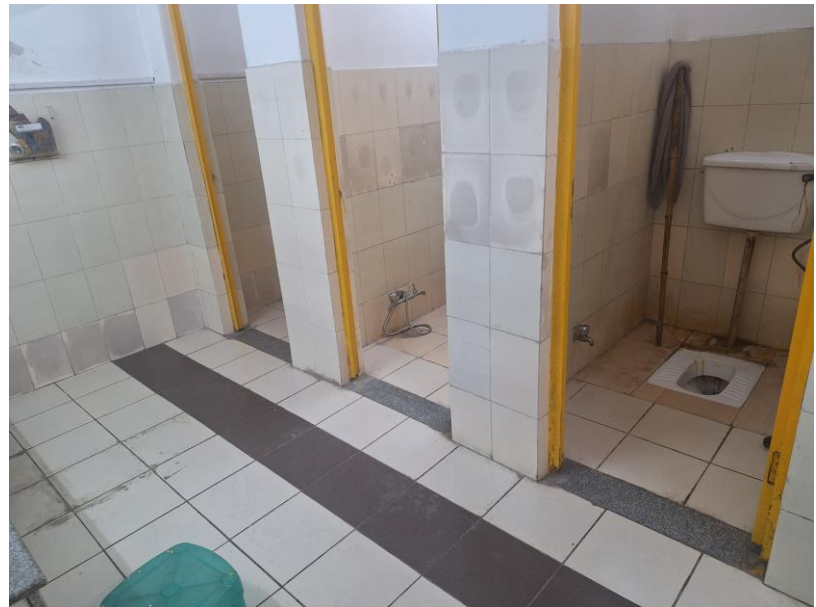
# Day care (Toilets for Children)

- Low level washbasins are provided.
- One Indian closet and 2 low level WC is provided for children.
- One staff toilet is inside the toilet.

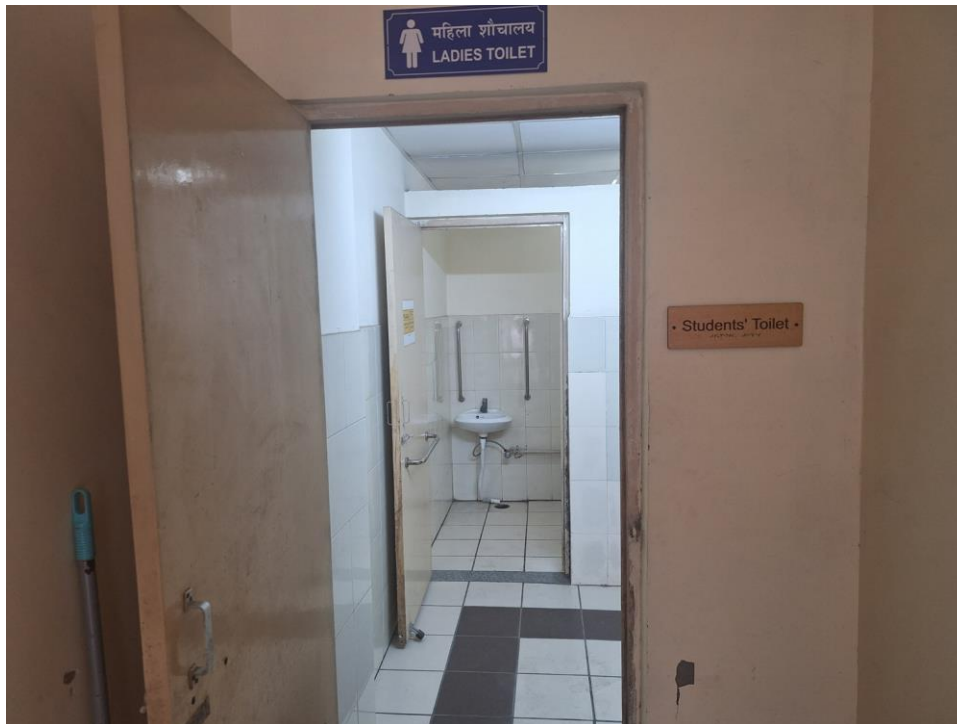
- TGSi is missing at the front of the door.
- There are 3 cubicles and 3 washbasins.
- Door opening accessing the toilet is 770mm wide.
- Washbasins are fixed at height of 804mm.
- Napkin dispensers and hooks shall be provided.

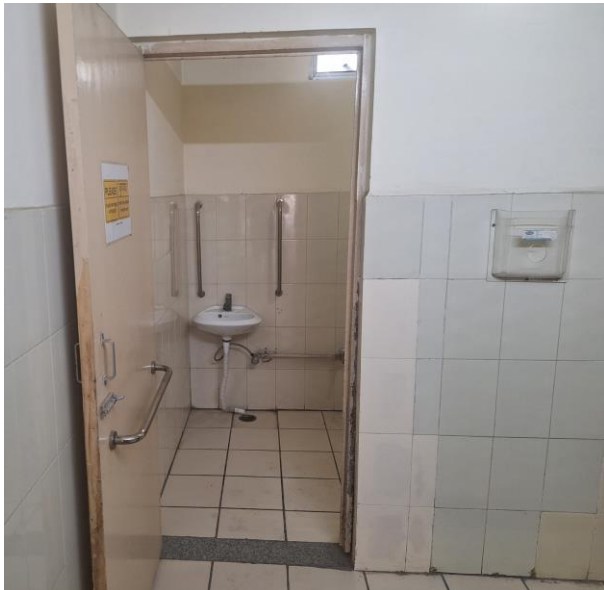
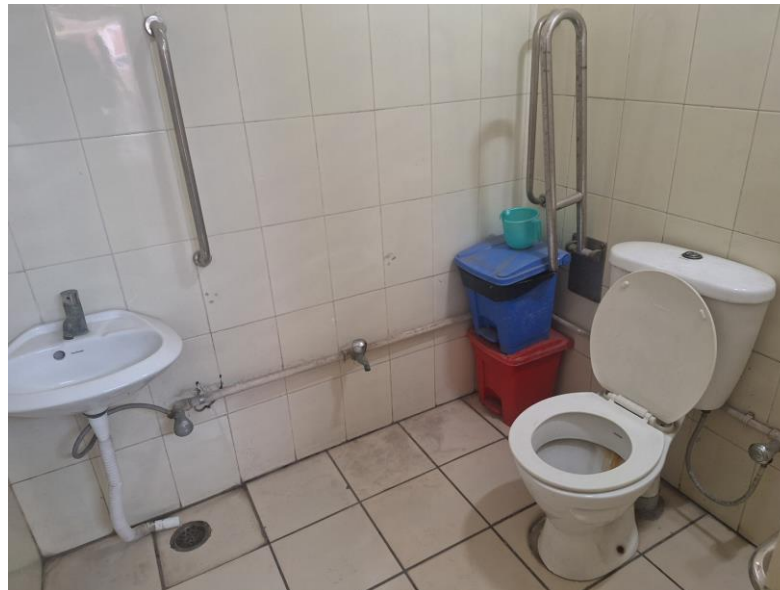
- TGSi warning is missing in front of the toilet.
- Size of the toilet is not meeting standards.
- Grab bars shall be improved.

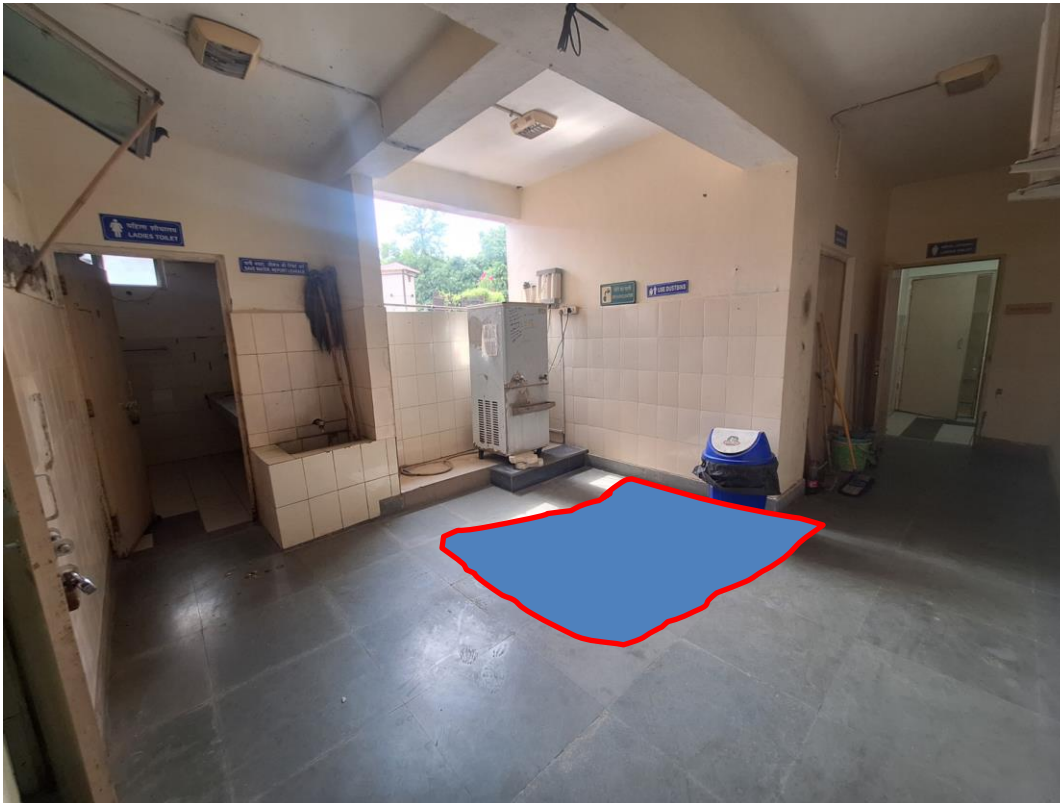
# Staff Toilet (Ladies)

- All Gender Accessible Toilet shall be provided in the new space recommended is indicated below.
- This space is well connected from the corridor and shall be provided at every floor except ground floor.

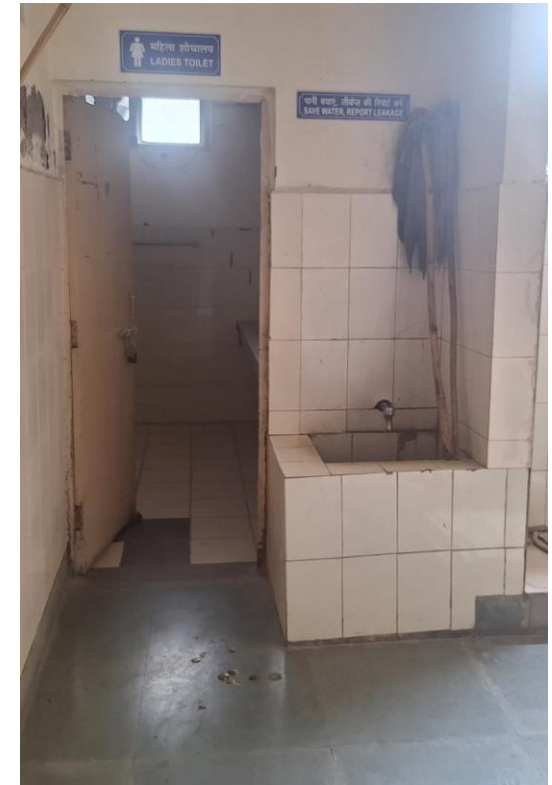
- TGSi is missing in front of the door.
- Door opening width is 804mm.
- There are 4 washbasins and 5 closets.
- Height of the washbasins are fixed at 802mm and depth is 509mm.
- The door accessing closet is 606mm.

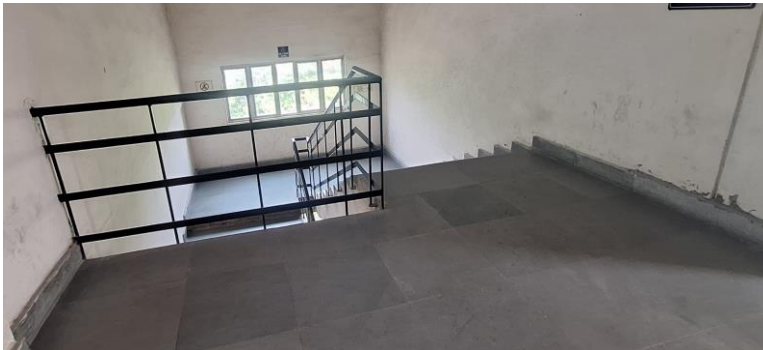
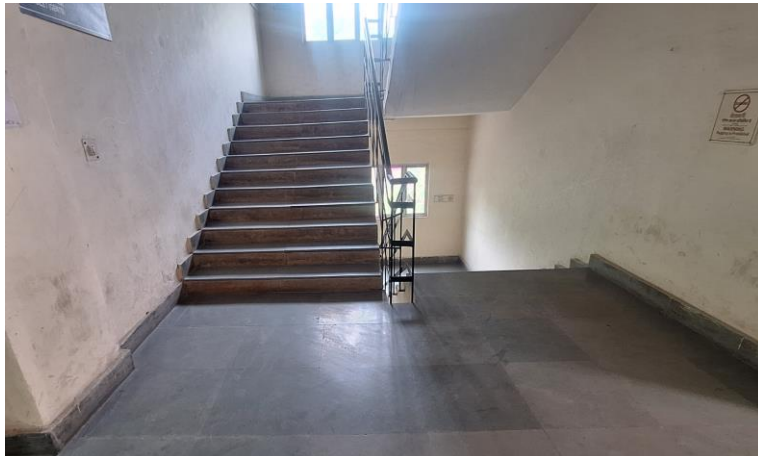
# Staircase connecting upper floors

- TGSi is missing at the start and end of the steps including landing.
- Handrails are not round handrail, instead flat handrail is provided. Also handrail is missing on one side of the staircase. **Refer page 58.**

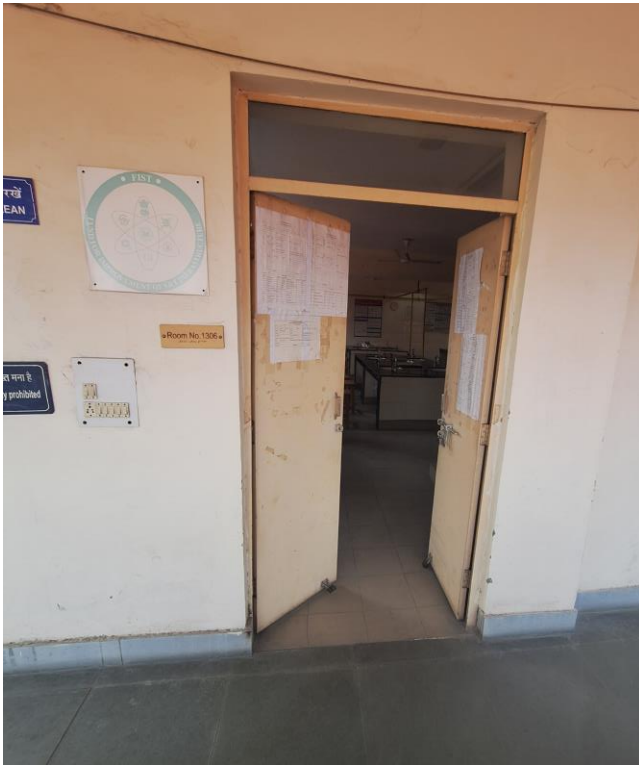
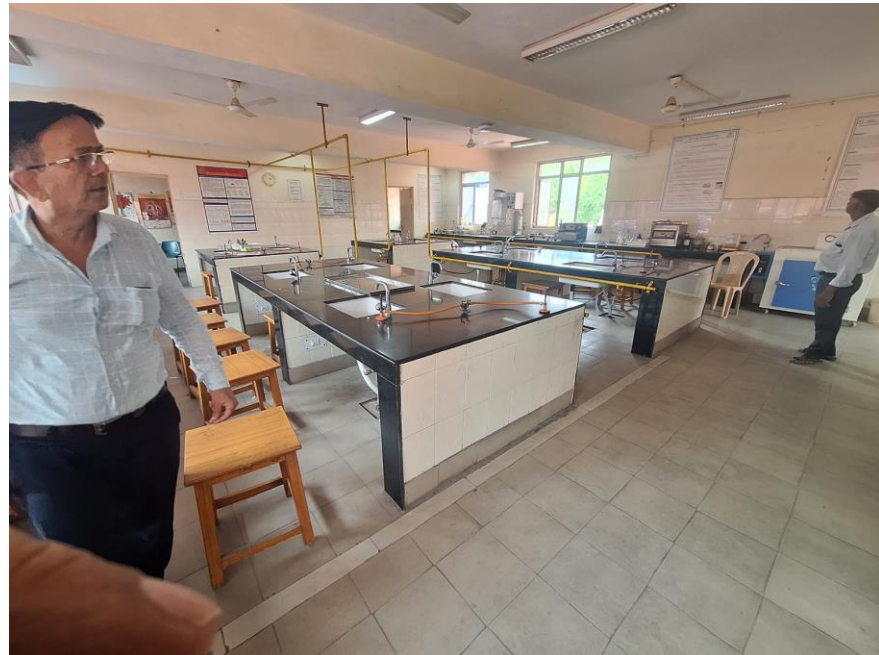
# Food Technology (upper floor)

- TGSi is missing.
- Signage is missing.
- Podium is provided without ramp. **Refer page 34.**
- Low level accessible sink with adjustable tap shall be provided.

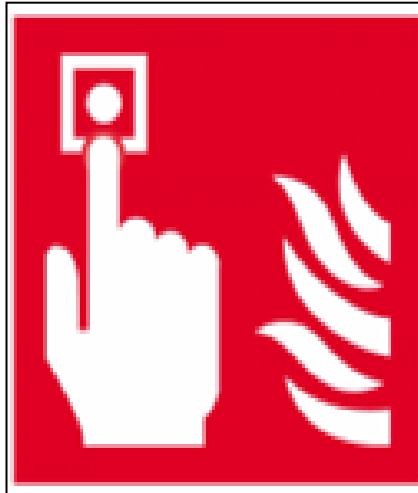
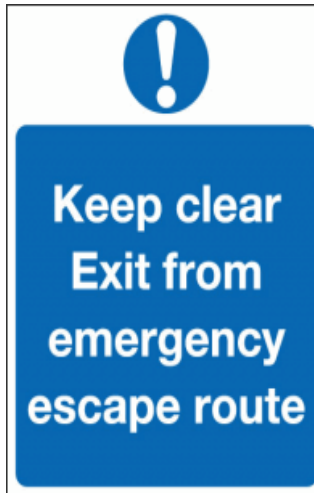
- Evacuation routes are clearly identified by floor signage in contrast colour.
- Emergency alarm both audio (hooter type) and visual (flashing bulb) to be provided at strategic locations to alert all people including those with hearing and visual impairments.
- Assembly area signage is provided and employees with disabilities shall be well oriented about the same.
