# Accessibility Audit Report

**Institute of Home Economics**

University of Delhi

1.07.2026

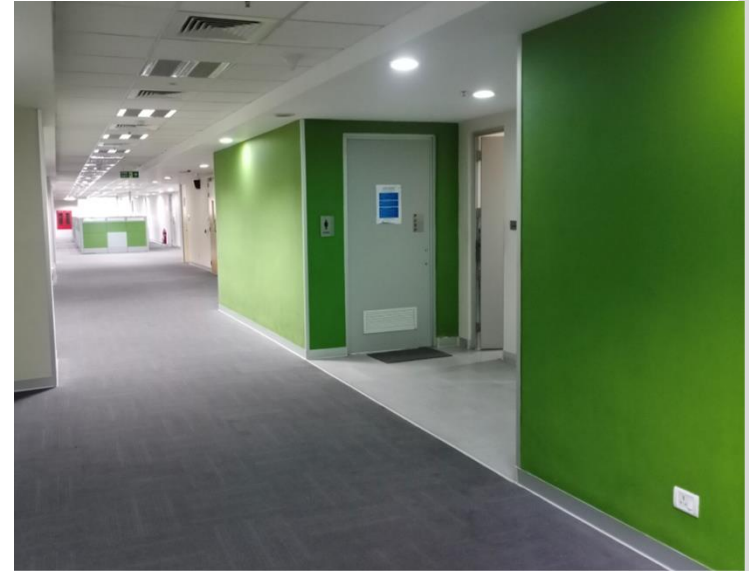
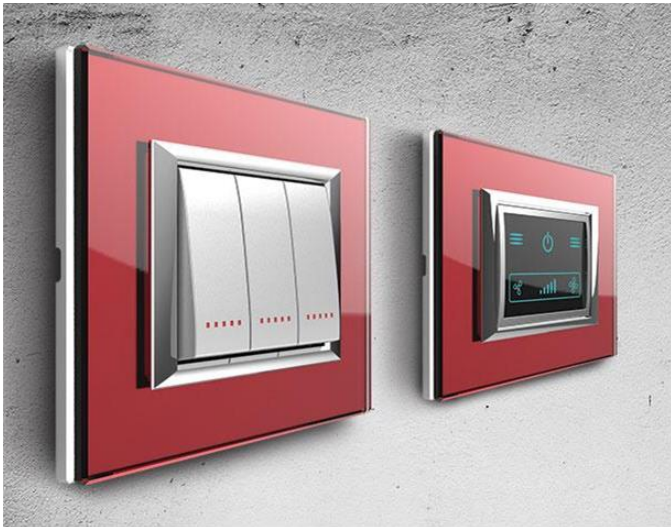
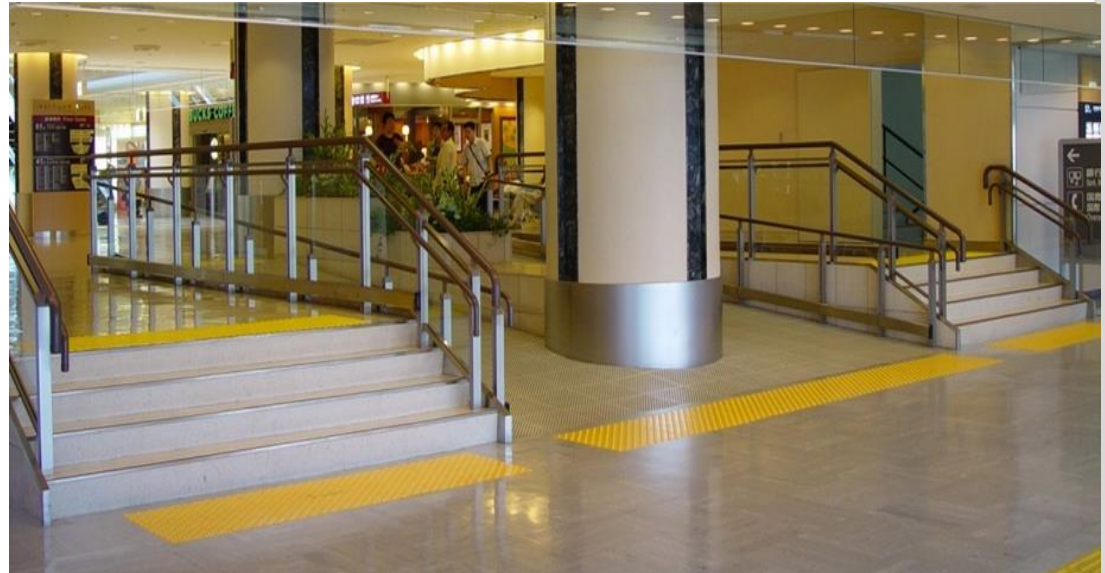
Contrast colours should be provided between:

- Signage and background sign frame/ wall,
- Step edges and risers/ treads on steps,
- Handrails and background wall,
- Doors and surrounding walls,
- Switches/ sockets and background wall,
- Toilet fixtures, accessories and background walls.
